Calapooia – Sodom Bifurcation Performance

Calapooia-Sodom Bifurcation Performance

- Review how we arrived today's configuration of the bifurcation
- Provide field data for actual split flow conditions
- Discuss project objectives for the bifurcation and how it is performing

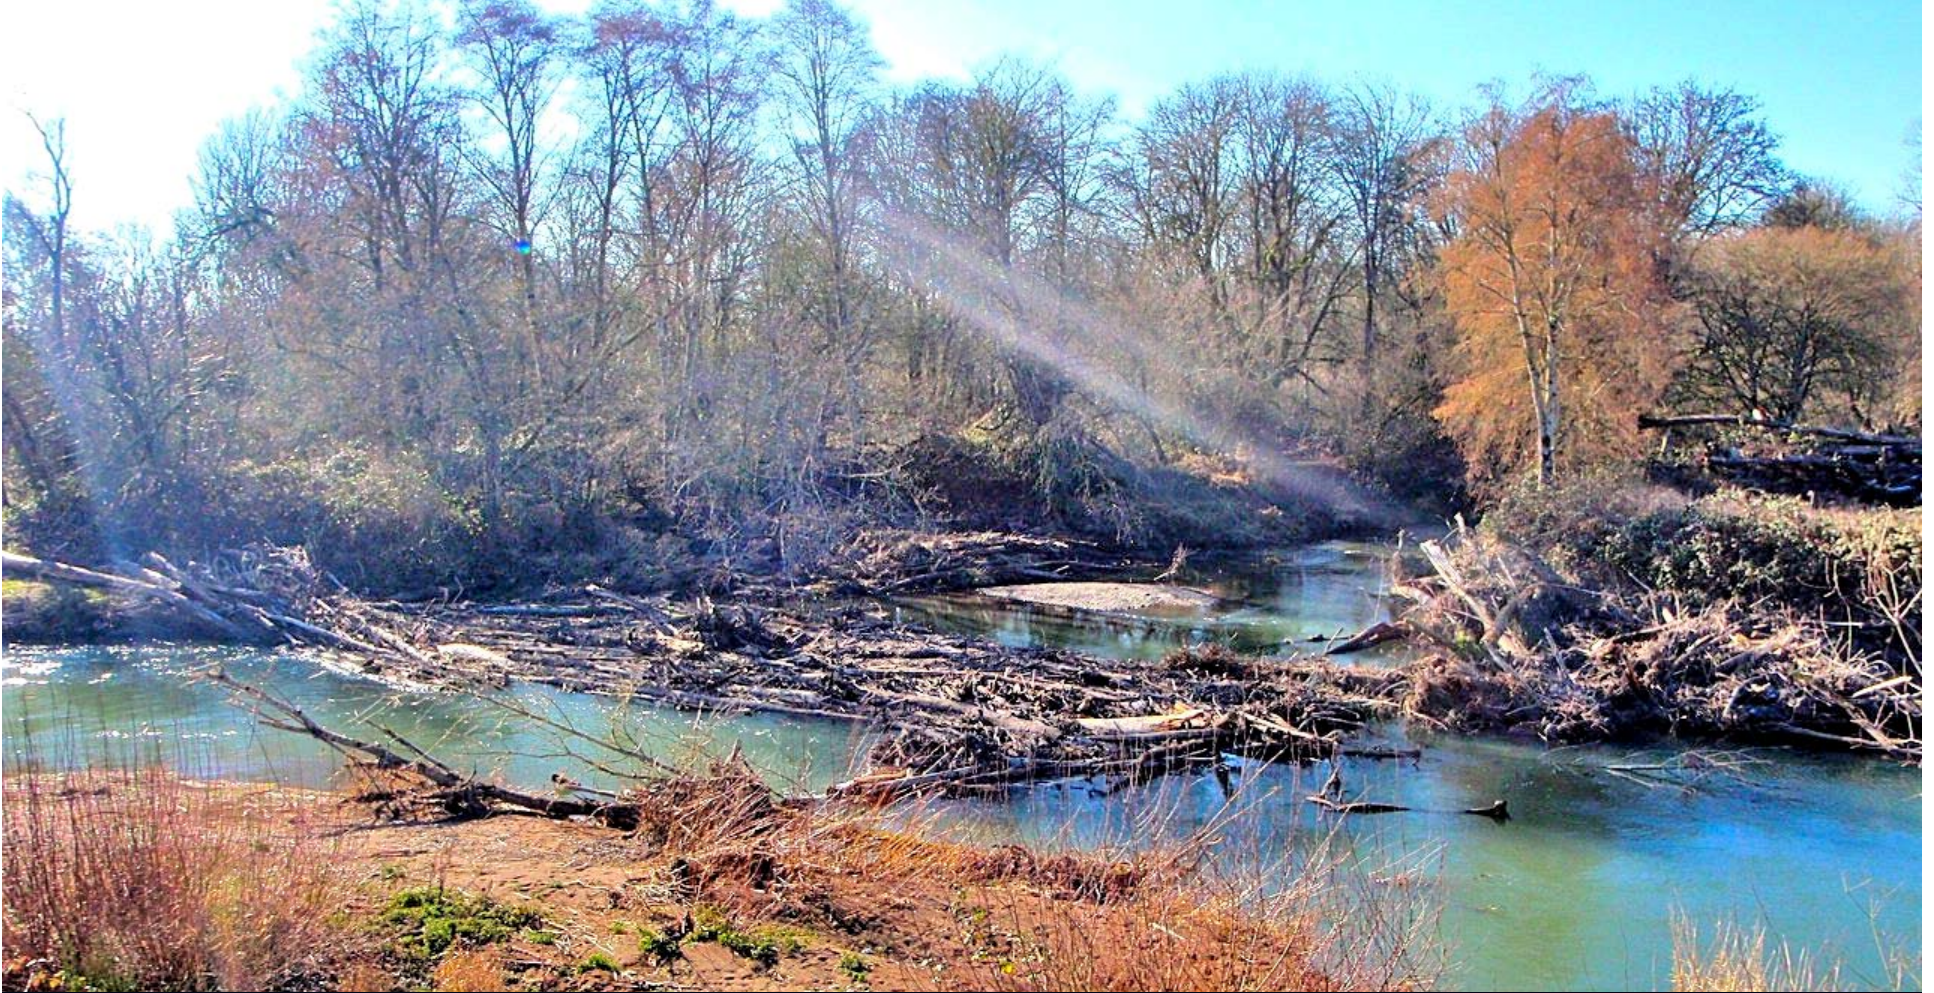
Bifurcation was on a trajectory of cutting off the Calapooia channel completely

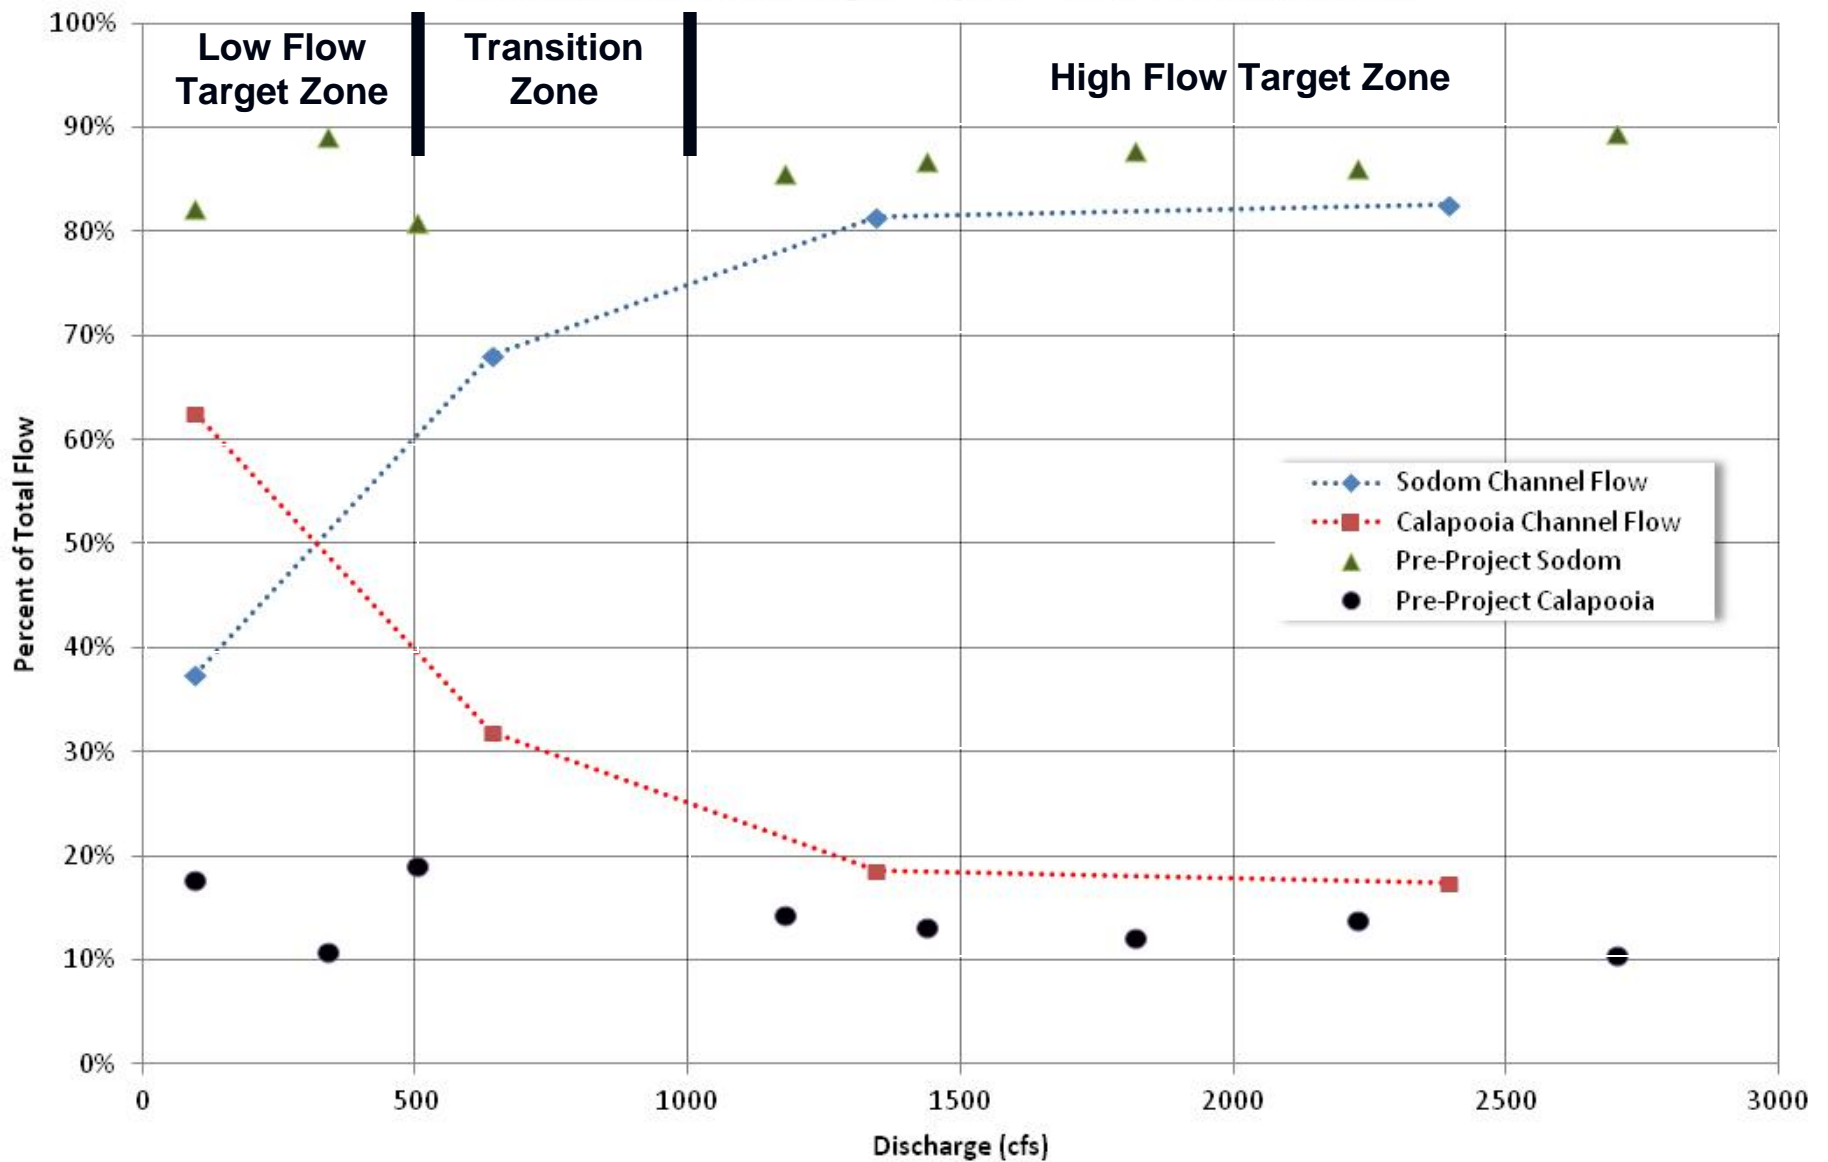
Measured Discharge - Split Flow Distribution

Field Data Collection Date	Calapooia River at Linn West		Sodom Channel at Linn West Road		Calapooia River Upstream of Bifurcation (cfs)
	Discharge (cfs)	Percent of Total Flow	Discharge (cfs)	Percent of Total Flow	
Nov. 5, 2009	17	18%	79	82%	96
June 16, 2010	96	19%	407	81%	503
Jan. 18, 2011	309	14%	1920	86%	2229
Feb. 8, 2011	37	11%	303	89%	340
March 10, 2011	221	12%	1600	88%	1821
March 16, 2011	284	11%	2420	89%	2704
April 7, 2011	190	13%	1250	87%	1440
April 8, 2011	170	14%	1010	86%	1180
Project Implementation					
December 22, 2011	60	63%	36	38%	96
January 4, 2012	204	32%	437	68%	641
February 22, 2012	250	19%	1097	81%	1347
March 23, 2012	415	17%	1979	83%	2394

- The bifurcation flow split is within the design parameters for high flow conditions of 70/30
- The design to minimize maintenance at the bifurcation appears to be working well
- The bifurcation is dynamic and can change after each large storm event

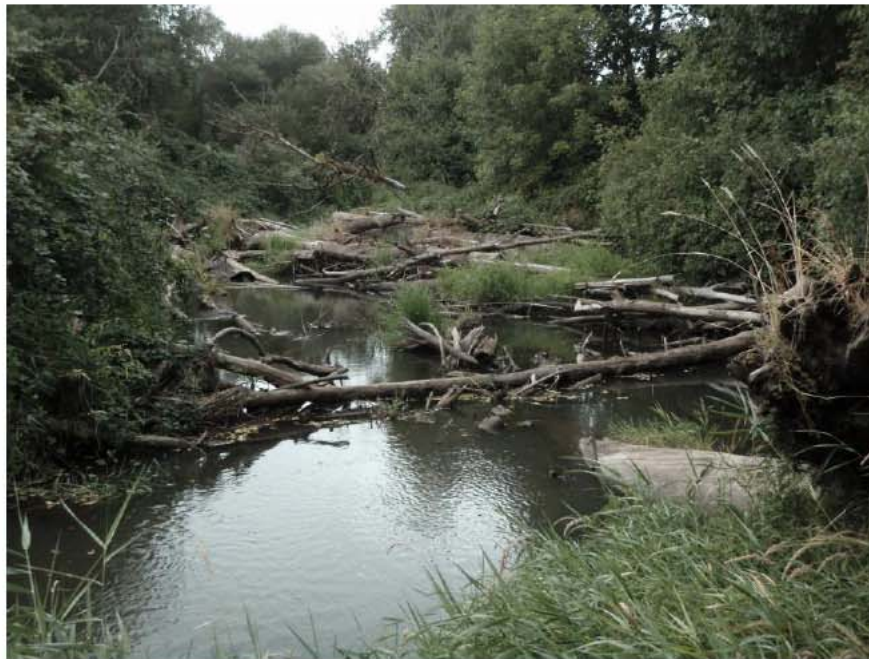
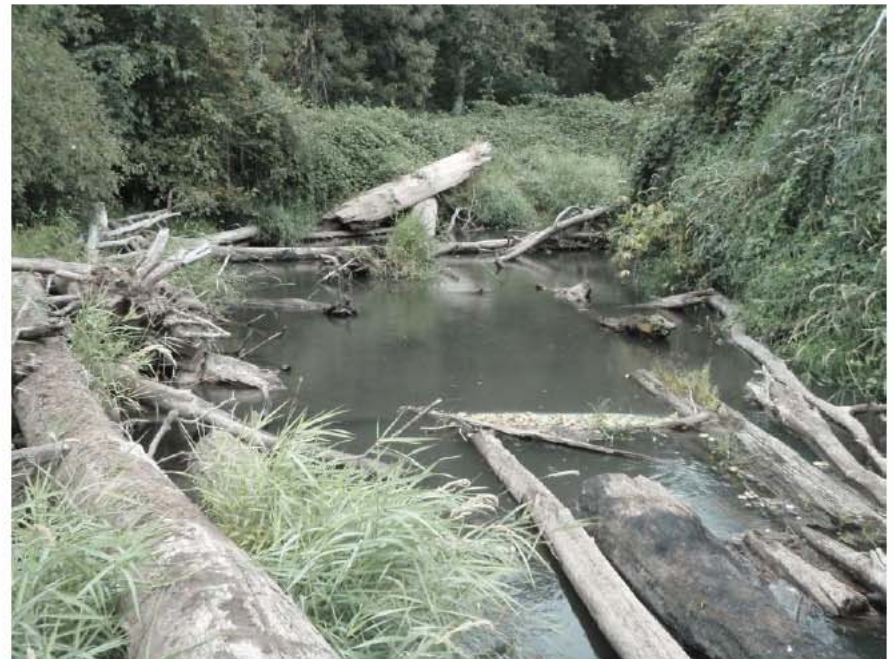
Log Jams in Calapooia

- OSU identified 25 log jams between bifurcation and I-5
