MIDDLE CALAPOOIA RIVER ASSESSMENT AND PROJECT IMPLEMENTATION PLAN

EXECUTIVE SUMMARY

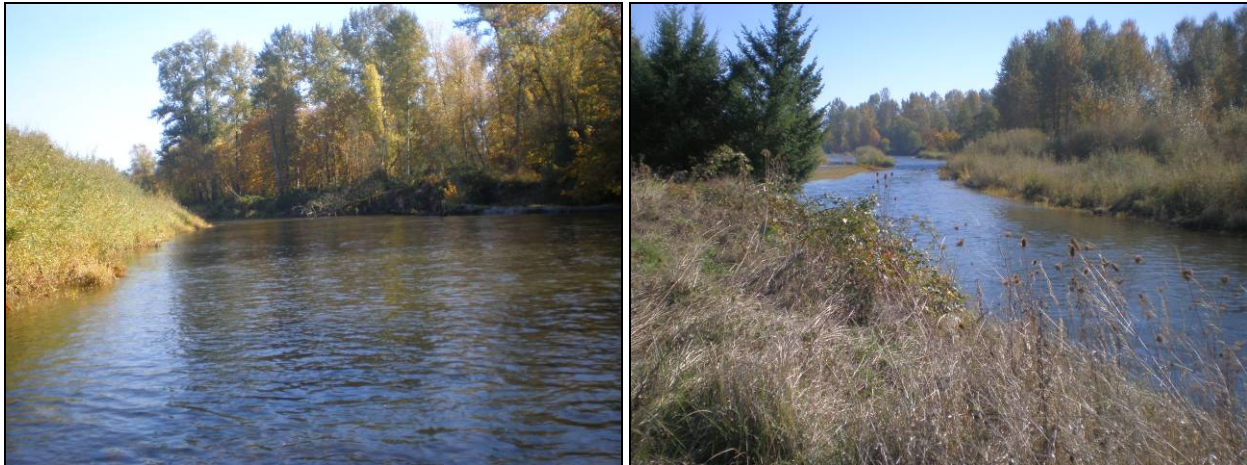
Figure 3-1. Examples of riparian conditions in the Middle Reach of the Calapooia River. Multiple age classes of willows populate depositional features, while mature floodplain forests characterize older floodplains (left). Varied riparian conditions exemplify much of the Middle Reach (right).

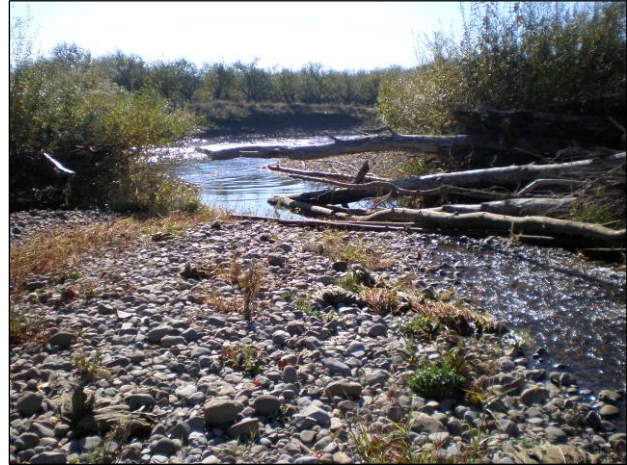
Figure 3-2. An example of a backwater habitat that provides juvenile rearing habitat connected to the river.

Rearing: Juveniles rear in the upper river and smaller tributaries for as long as 4 years in fresh water; prefer pools with cover, large wood (Figure 3-2), and cool water temperatures (less than 64 °F), and high dissolved oxygen levels.

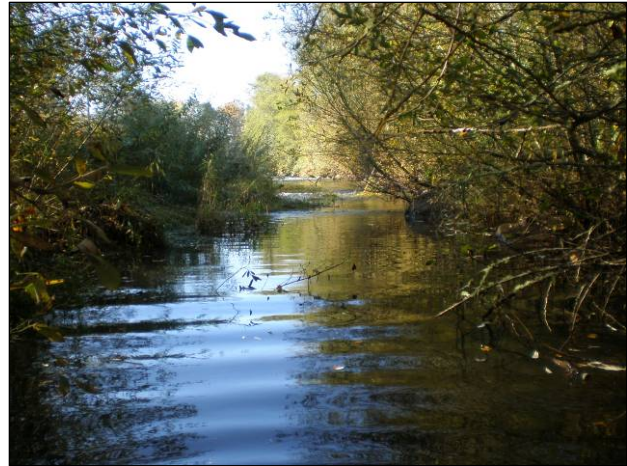
Figure 3-3. An example of a floodplain channel that is inundated over a range of mainstem stages. These habitats provide off-channel habitat for fish and amphibians.

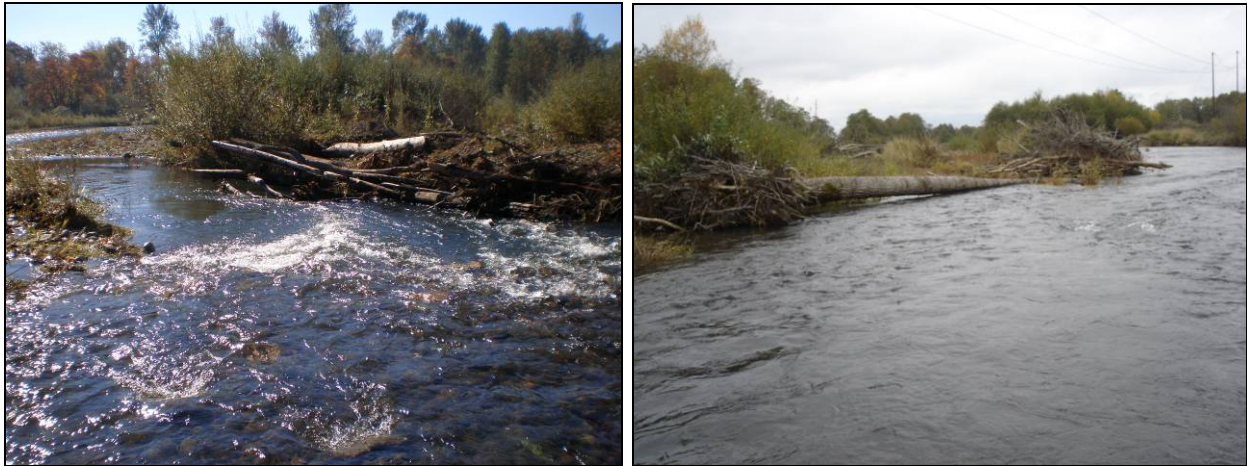
Figure 3-4. Large wood provides overhead cover for fish habitat and also influences channel morphology. Large wood is a vital component for maintaining fish habitat in the Calapooia River.

Large wood historically played an important role in creating habitat diversity (Figure 3-4). However, log drives, riparian logging, and removal of large wood from the river and tributaries have reduced the prevalence of habitat-forming trees in the Middle Calapooia River. Similar to other areas in the Willamette Valley, logs on the floodplain are cut either for firewood or to reduce the chance of logs damaging property or infrastructure during floods (Figure 3-5). Large wood is important for fish in streams and rivers because it creates pools, hiding areas, bars of gravel that are sorted by size, and is a substrate for aquatic insects.

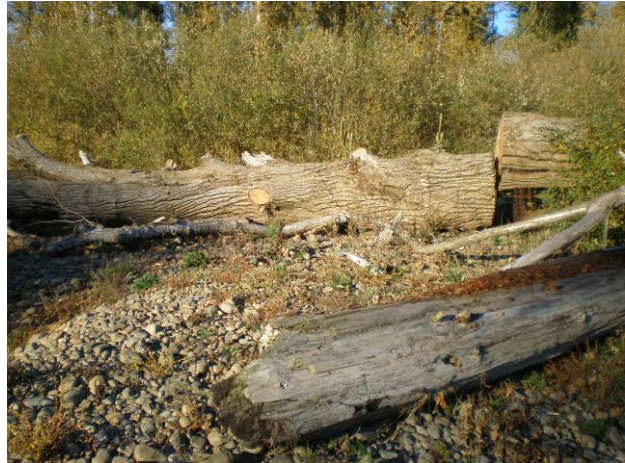
Figure 3-5. An example of a large log on the Calapooia River floodplain upstream from Brownsville that was recently cut. The log will no longer function as a habitat forming element.

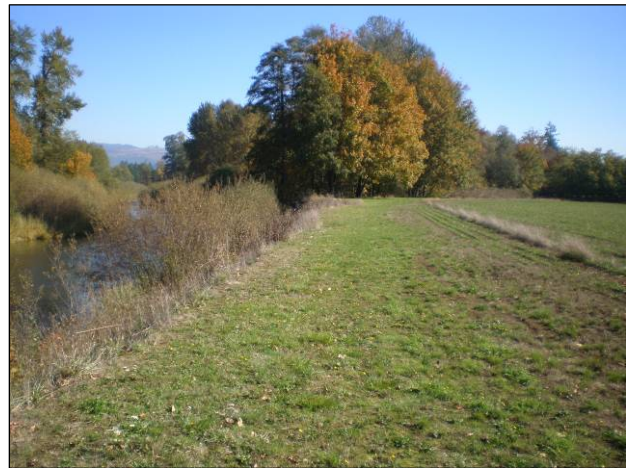
Figure 3-6. A grass seed field paralleling the Calapooia River. The site is characterized by a minimal riparian buffer separating the river from agricultural production.

Grass seed farming is an important agricultural occupation in the Calapooia River watershed (Figure 3-6). Improving agricultural practices would address nitrogen fertilizer runoff to the river. Compared to cultivated riparian zones, non-cultivated riparian zones are very effective at removing nitrogen from subsurface water draining into a stream. However, due to flow patterns and the speed of surface runoff, while retaining riparian vegetation is generally beneficial to streams, the benefits do not include mitigating nitrogen runoff. The most effective means to control nitrogen runoff from grass seed fields begin with applying only the minimum amount of fertilizer needed to grow a crop and that the timing of the fertilizer coincide with periods of drier weather.

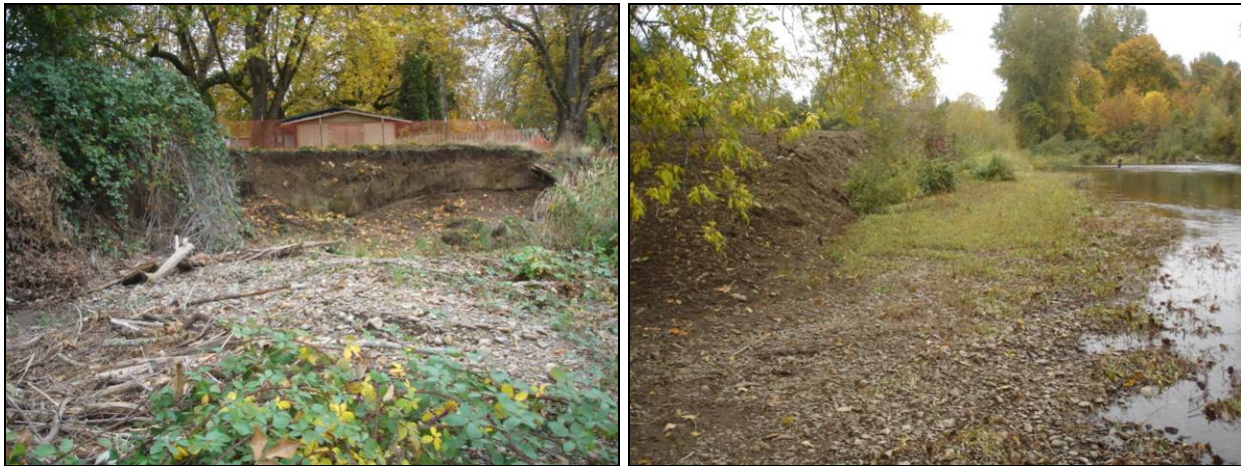
Figure 3-7. Working with landowners to address accelerated bank erosion (left) and providing alternatives to dumping fill along the channel (right), are two educational efforts that can be pursued to reduce sediment loading to the Calapooia River as well as slow property loss.

Where rivers have been treated in such a way, conflicts among landowners and declines in fish habitat invariably occur (Figure 3-7). In addition, stopping the meandering on one segment of river usually causes an upstream or downstream increase in meandering and erosion, often creating problems for neighboring landowners. By decreasing the meandering of a river, water velocity increases, the river bottom downcuts, gravel bars become coarser, and zones of still water decrease; all of which are detrimental to fish. Treating a bank to control meandering can not be justified on the grounds of decreasing overall river sediment loads, since the amount of bank material is so small compared to the river's overall sediment load.

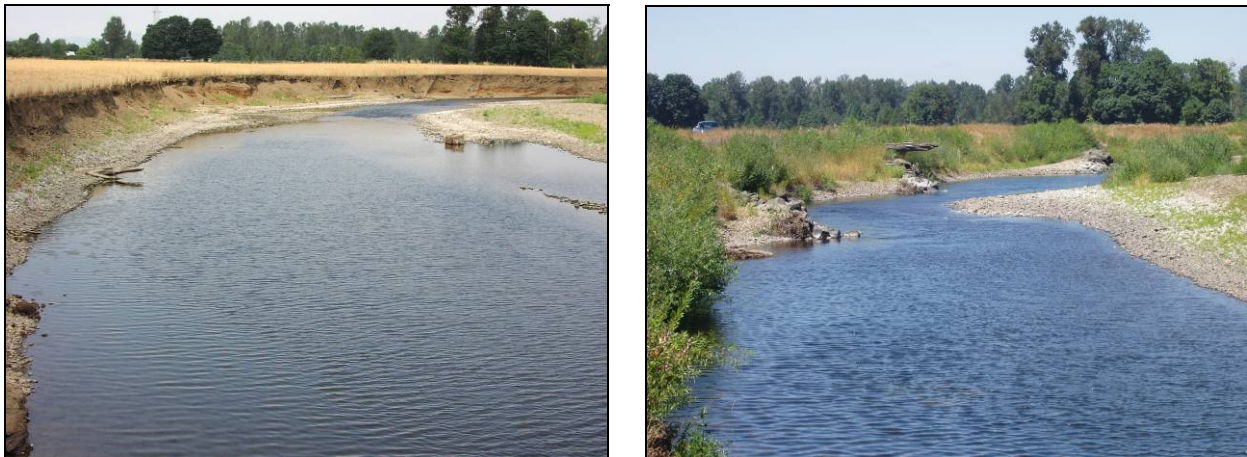
Figure 4-1. Examples of eroding bank (left) at the Carbajal site pre-project and more recent (right) photo showing effects of bank stabilization using rock barbs and revegetation.

Bank stabilization projects, using rock barbs, are located at three sites. These projects consist of variations using rock barbs, bank re-shaping, vegetation, and/or large wood. For the most part, the barb projects have stabilized bank erosion as illustrated by the Carbajal site (station 104+00 to 111+00) in Figure 4-1. The landowner was losing over 10 ft of streambank every year with some localized erosion exceeding 25 ft per year due to lateral erosion prior to the project. Now, the bank has been stabilized and a riparian corridor has been established that consists of willows on the bank and trees and shrubs on the floodplain. At the Oakley site just upstream (station 68+00), the bank stabilization project was not revegetated as well and is showing signs of additional bank erosion.

While these bank stabilization projects have been largely successful at halting lateral erosion, the project start and finish transition areas are exhibiting signs of additional erosion. It is recommended to provide additional stabilization at these points to preserve the investment that was previously made and increase habitat complexity. Treatments should address the entire bank profile, from the bank toe to the top of bank. Continued bank erosion is most likely related to the original treatments not being carried upstream and downstream a sufficient distance.

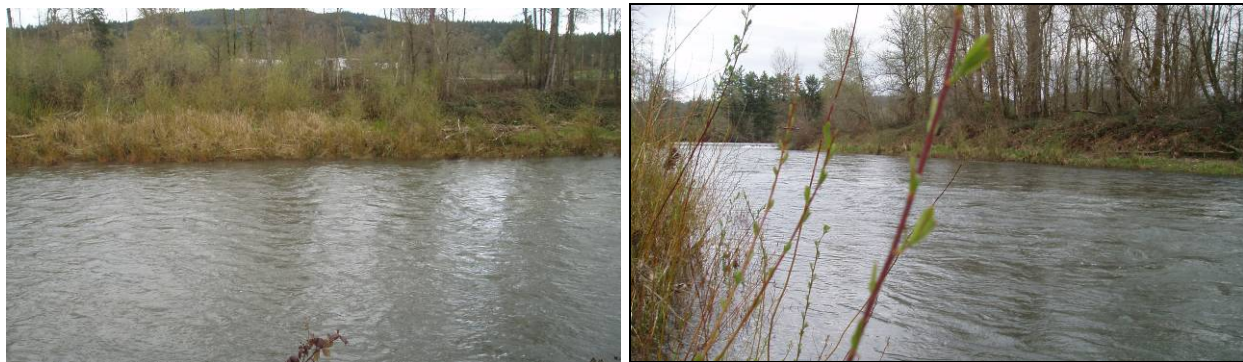
Figure 4-2 depicts the cross-section at Sta. 6+00. The photos capture the features surveyed in the cross-section. For example, the flat inset floodplain in the right portion of the channel cross-section immediately above the estimated bankfull elevation, is the willow surface in the upper left photograph. The low terrace shown forming the left bank in the cross-section figure is captured in the upper right photograph.

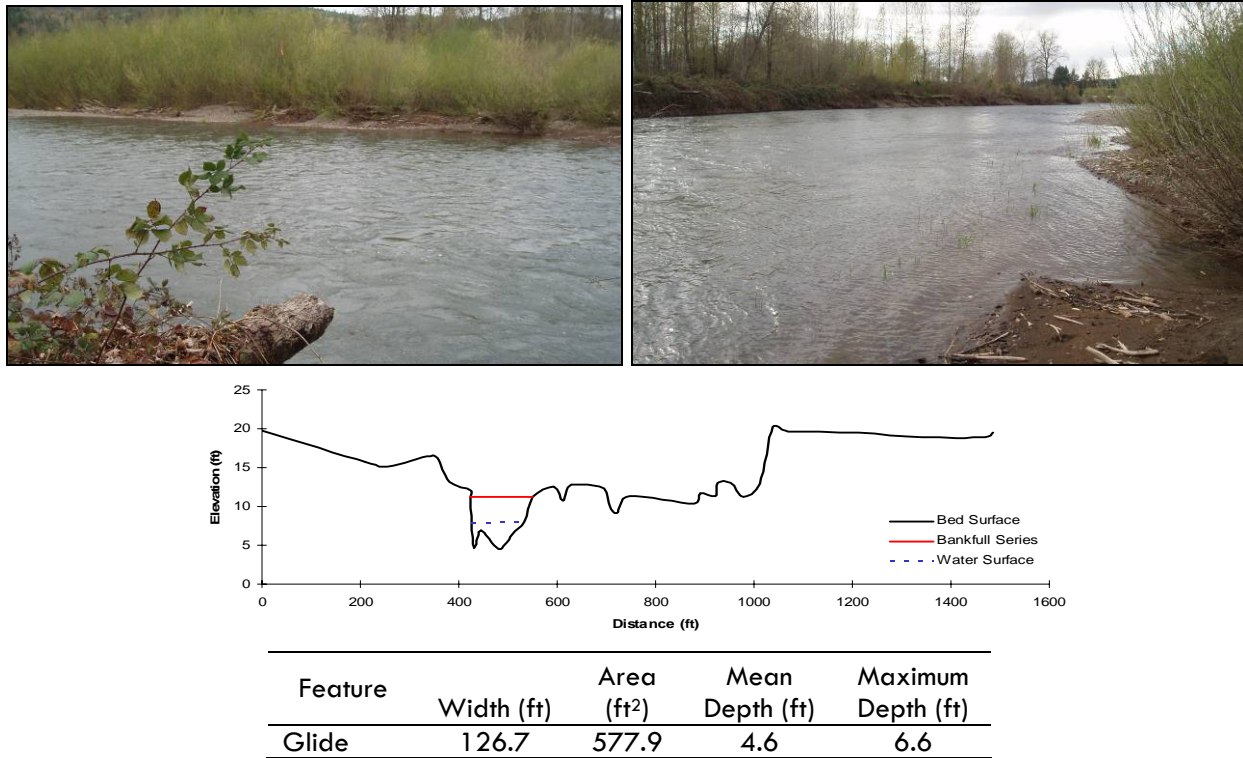
Figure 4-3. The cross-section at Sta. 29+00 in the Rosgen C4 stream type portion of Reach 1. The upper left photo shows the right floodplain noted by the flat in the right portion of the cross-section diagram. The upper right photo is a view down river towards the left bank. The beltwidth is almost twice as wide at Sta. 29+00 compared to Sta. 6+00, a Rosgen B4c stream type.

diverse floodplain morphologies are typically associated with a broadening of the channel beltwidth. The undulations of the floodplain shown in Figure 4-3 show the multiple sidechannels and swales that are located on the floodplain north of the baseflow channel. Focusing restoration efforts on these areas of the stream corridor is suggested for enhancing juvenile fish rearing habitat and refugia.

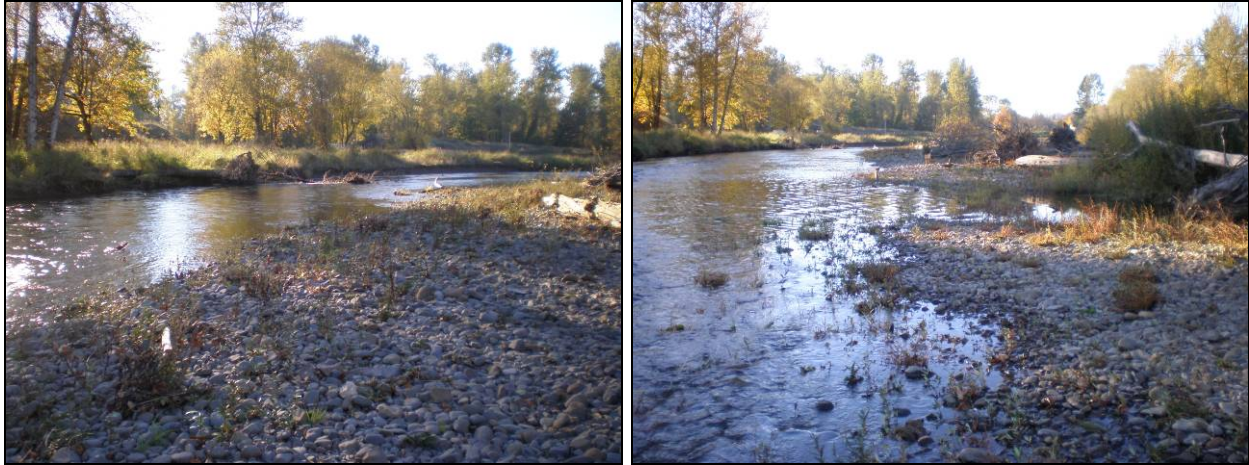
Figure 4-4. Typical vegetation conditions on the southern floodplain (left) and a point bar with backwater habitat (right).

The floodplain morphology in the reach is influenced by the valley bottom width and river processes. At the beginning of the reach in the C stream type section, the valley bottom width permits narrow floodplain development. The riparian community is dominated by a cottonwood overstory and willow shrub layer. Several large point bars between the start of Reach 3 and the Brownsville Bridge suggest a mobile streambed and localized sediment storage. A dispersed riparian canopy is located on the southern floodplain. Vegetation patterns reflect the agricultural practices that predominate on the south side of the Calapooia River upstream of the Brownsville Bridge. Figure 4-4 includes some typical photographs of the upstream half of Reach 2.

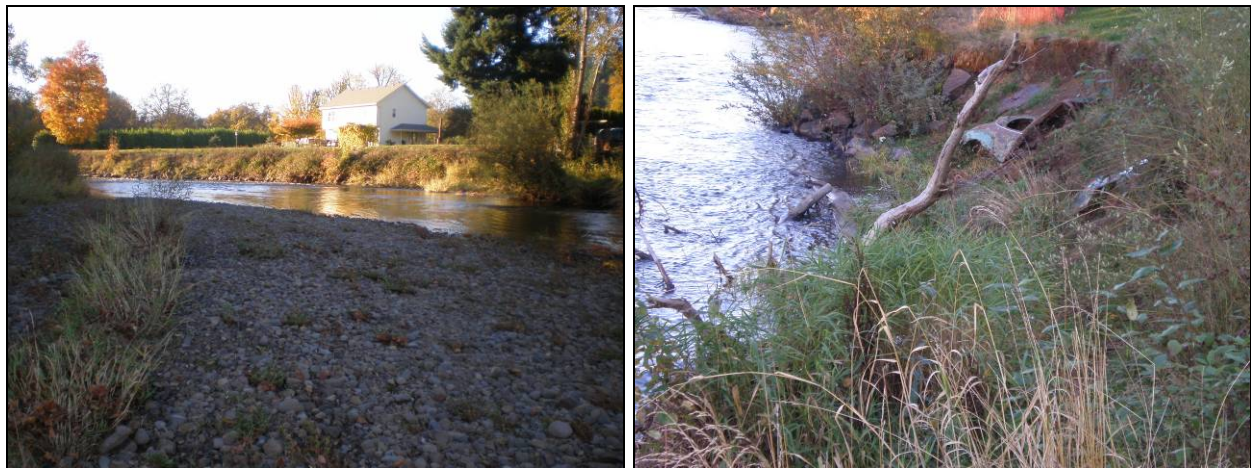
Figure 4-5. Bank stabilization sites in Reach 2 include the house protection at Sta. 160+00 (left) and at Pioneer Park.

Two riprap sites were identified upstream of Brownsville Bridge. The upstream site protects a residence built adjacent to the river. The downstream site appears to be at a former river crossing location. The treated area is localized. Downstream of the Brownsville Bridge, the left bank is stabilized for approximately 2,000 ft. This project was likely implemented in the early 1960s when an extensive bank stabilization effort was undertaken. A concrete slab immediately downstream from the bridge may be an old crossing or the remnant of some other infrastructure. Figure 4-5 illustrates bank stabilization treatments in Reach 2.

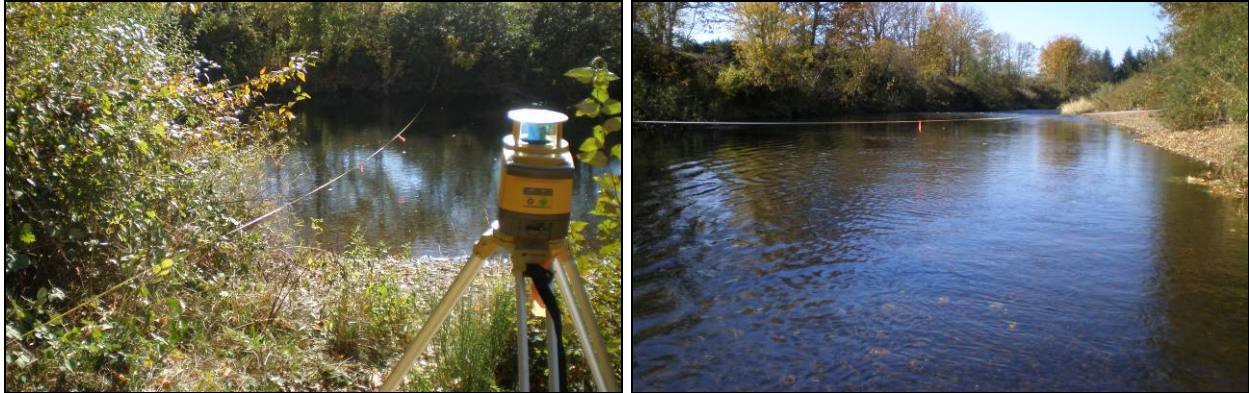
A hydraulic channel cross-section was established in Reach 2 adjacent to Pioneer Park downstream from Brownsville Bridge. A channel survey was completed on October 25, 2007. The survey included a cross-section, channel profile, discharge measurement, and pebble count in the C stream type portion of Reach 2. Summary information from the survey is included in Figure 4-6. The photos capture typical river corridor conditions in the vicinity of Pioneer Park. The left bank is stabilized with riprap. The right bank is a point bar with medium density riparian vegetation at the topographic break. The right floodplain has been kept in a moderately natural state with a riparian canopy and grass floodplain surface. The shrub layer that would be expected in a more natural setting was removed in the past to create the park conditions. The cross-section also exhibits the sloped point bar and flat channel bottom that predominates through the park section of the Calapooia River.

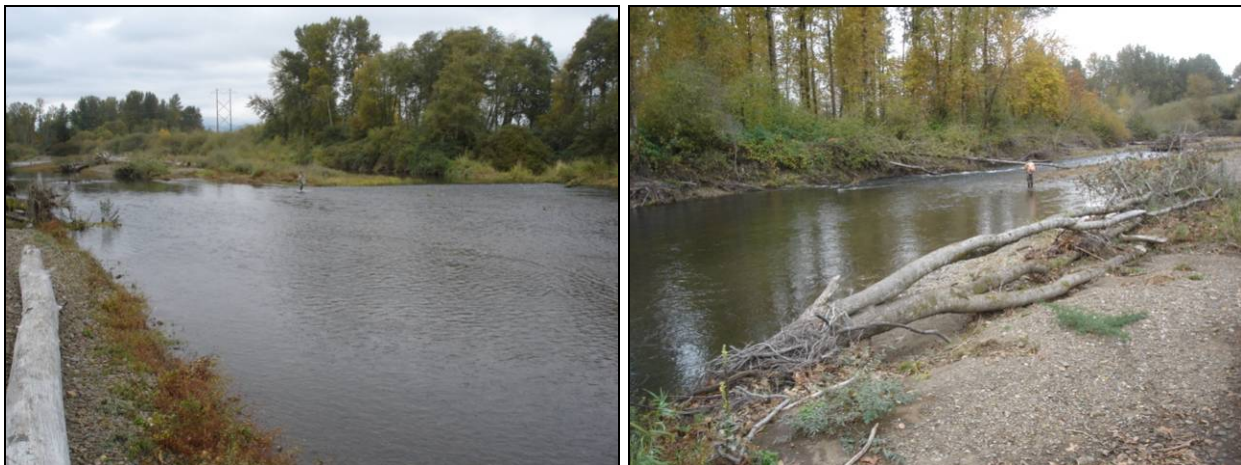
Figure 4-7. Backwater channels and large wood in Reach 3 provide a range of habitats that benefit juvenile and adult fish in the Calapooia River.

Floodplain expanses in Reach 3 provide a range of habitats beneficial for both fish and wildlife. Backwater habitats, groundwater-fed percolation channels, and floodplain ponds are inundated year round but may only be connected with the mainstem Calapooia River during elevated flows (Figure 4-7). Hyporheic (shallow subsurface flow) or groundwater upwelling in these floodplain features provide cool water refugia for fish during warmer summer months. Shallow channel margins also create cover for juvenile fish. Habitats containing large wood provide complex microhabitats for juvenile fish as well.

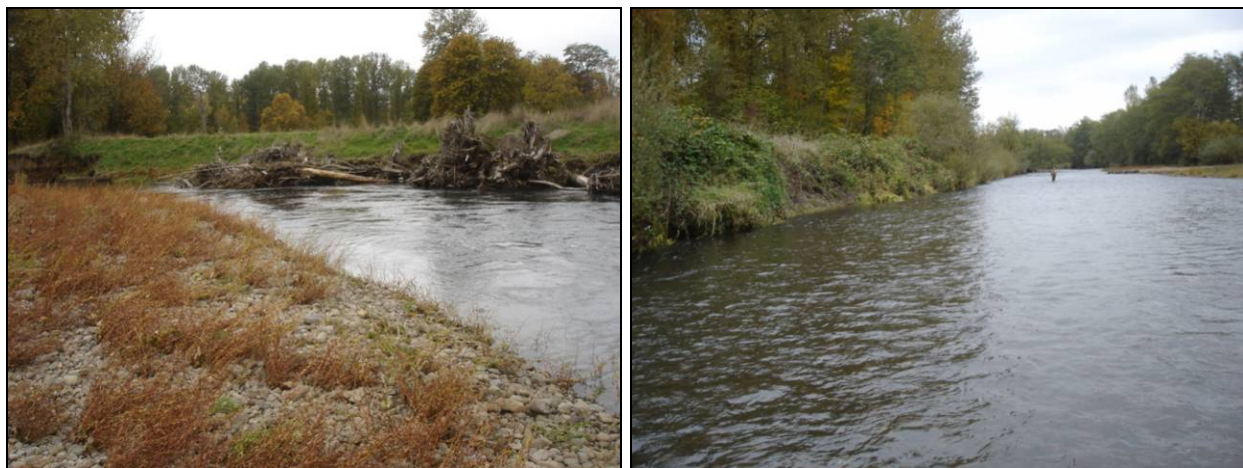
Figure 4-8. Examples of bank stabilization in Reach 3 include the Ross site (left) and an older riprap project spanning 2,000 ft from Sta. 242+00 to 262+00 (right).

Five riprap sites and a rock spur were located in the reach. Riprap sites were generally extensive and protect adjacent agricultural land. The riprap was likely installed during the 1962 effort and is largely grown over with shrubs, blackberry, and overstory deciduous trees. The Ross bank stabilization site included bank re-grading, four engineered log jams, and riparian plantings. The downstream riprap sites stabilize streambanks adjacent to agricultural fields. Figure 4-8 depicts bank stabilization projects in Reach 3.

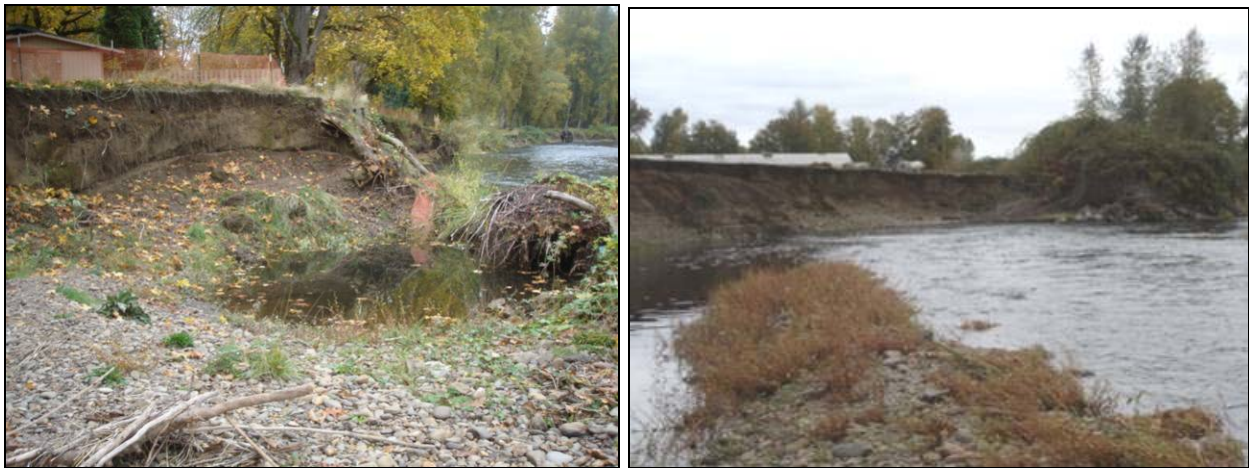
Figure 4-9. The bank erosion site downstream from Pioneer Park that continues onto the Gerber and Smith properties (left), and the vertical streambank on the Nealon property (right). The blackberry covered structure in the middle of the right photograph is a rock spur or levee.

The extensive riprap bank stabilization in Reach 3 limits lateral channel migration and related streambank erosion. However, there are four primary bank erosion areas in the reach. The first site, located downstream from Pioneer Park is experiencing accelerated bank retreat caused by eddying. The bank failure is threatening one of the park buildings and continues to erode the adjacent neighbor’s property (Figure 4-10). The river is also eroding the floodplain downstream from the Ross project. The streambank has experienced accelerated erosion since 2005 (Inter-fluve 2007). This trend is expected to continue as the river migrates down-valley over time. The Nealon property located in the next meander downstream from the Ross property is also experiencing accelerated streambank failure. The vertical bank has a poor riparian condition and no toe protection capable of withstanding flood hydraulics (see Figure 4-9). The final primary bank erosion site is located on an outside meander downstream from an extensive riprap bank. Located from Sta. 262+00 to 268+00, the Calapooia River is eroding a forested floodplain. Bank erosion will recruit mature trees to the river. Other sediment sources in the reach are relatively isolated and smaller scale. Table 4-19 includes sediment source metrics in Reach 3.

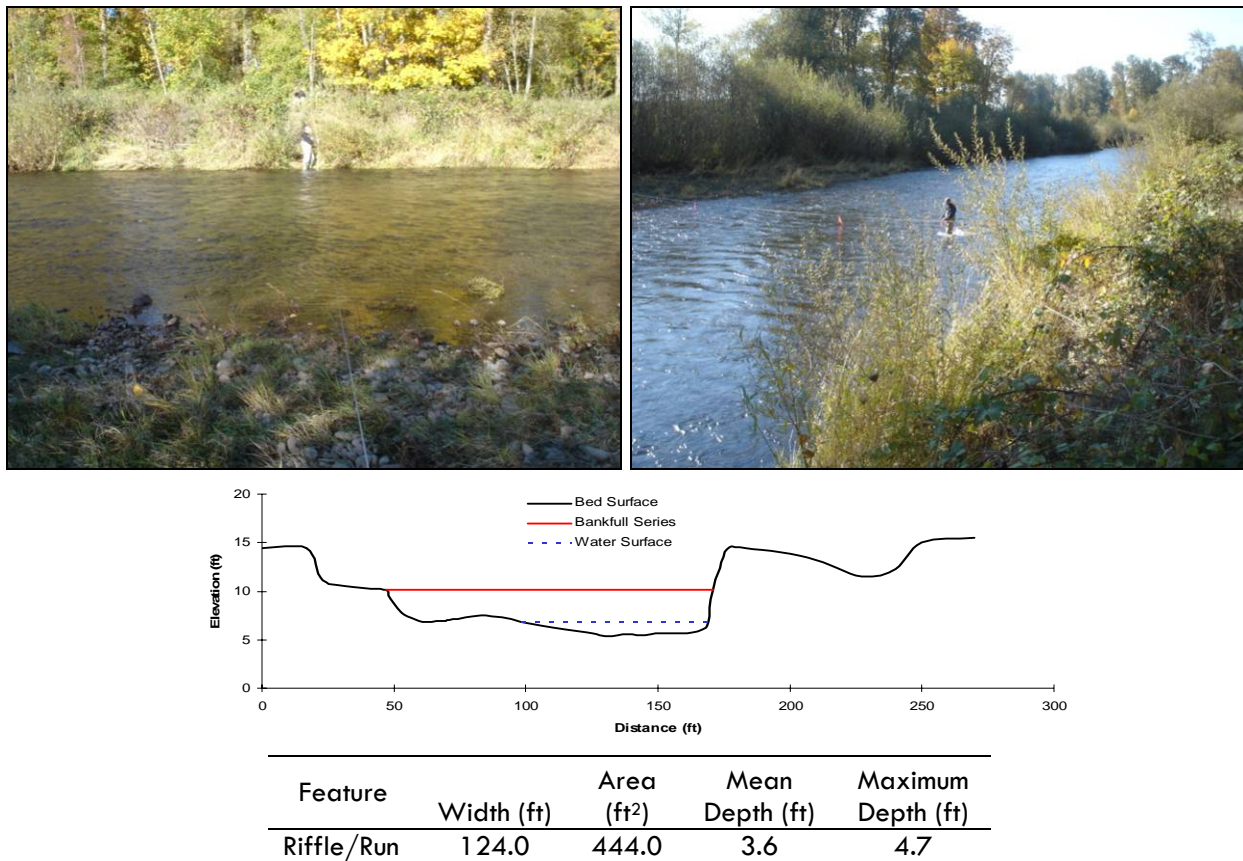
Figure 4-10. The cross-section at Sta. 254+00. The upper left photo shows a view across the river from the left bank. The right photo captures the river corridor through the cross-section location.

A hydraulic channel cross-section was established in Reach 3 downstream from the Ross Property at the waste water discharge diffuser. A channel survey was completed on October 25, 2007. The survey included a cross-section, channel profile, discharge measurement, and pebble count. Summary information from the survey is included in Figure 4-10. The photos capture typical river corridor conditions in the vicinity of Pioneer Park. The left bank is stabilized with riprap. The right bank is point bar with moderately dense riparian vegetation at the topographic break. The right floodplain has been kept in a moderately natural state with a riparian canopy and grass floodplain surface. The shrub layer that would be expected in a more natural setting is mowed to maintain the park conditions. The cross-section also exhibits the moderately sloped point bar and flat channel bottom that predominates through the park section of the Calapooia River.

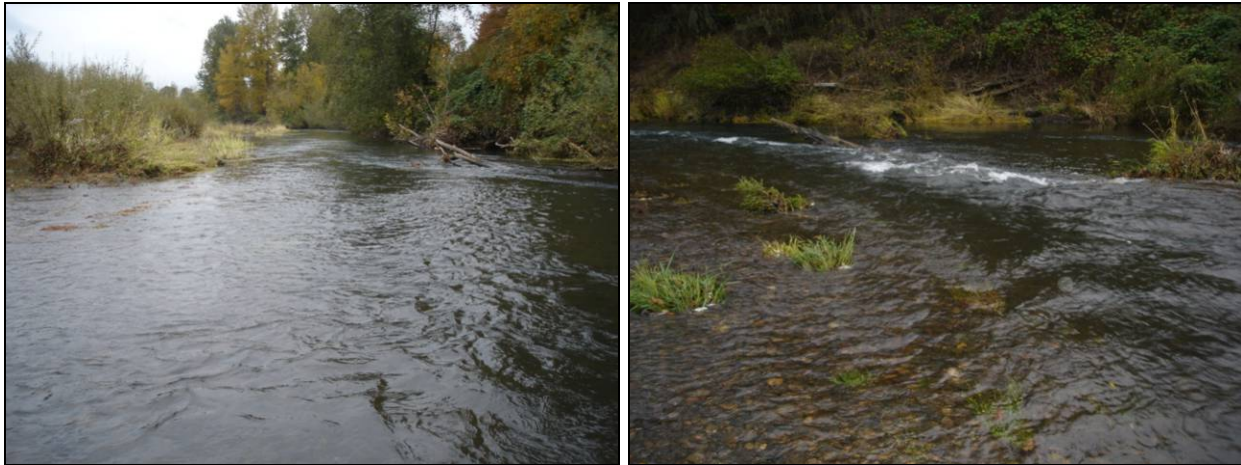
Figure 4-11. Example habitats in Reach 4 include glide-riffle transitions (left) and runs influenced by large wood (right).

The extensive glide habitats in the reach are related to the straight sections of the channel that have homogenous habitat conditions. Several of the pools were also located through the reach. Large wood anchored in the river bed provided flow divergence and habitat diversity (Figure 4-11).

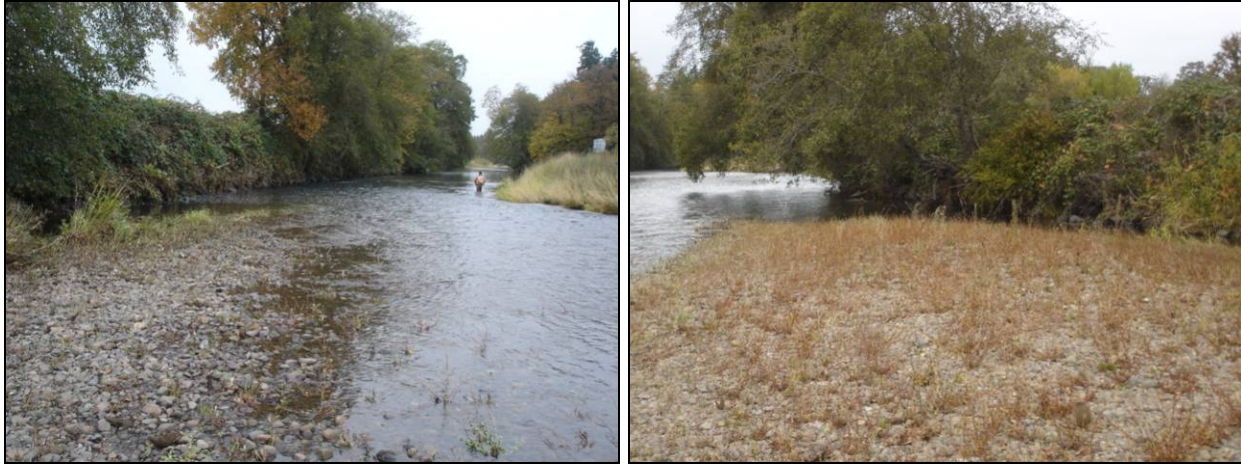
Figure 4-12. Examples of bank stabilization in Reach 4. The left bank is stabilized in upper Reach 4 (left). Blackberry bushes and deciduous trees have colonized the riprap. The right photograph shows a backwater habitat that has formed between a gravel bar and the adjacent riprap bank at station 309+00.

The riprap sites were generally short and were likely installed during the 1962 effort. Riprap is largely grown over with shrubs, blackberry, and overstory deciduous trees. Figure 4-12 depicts bank stabilization projects in Reach 4.

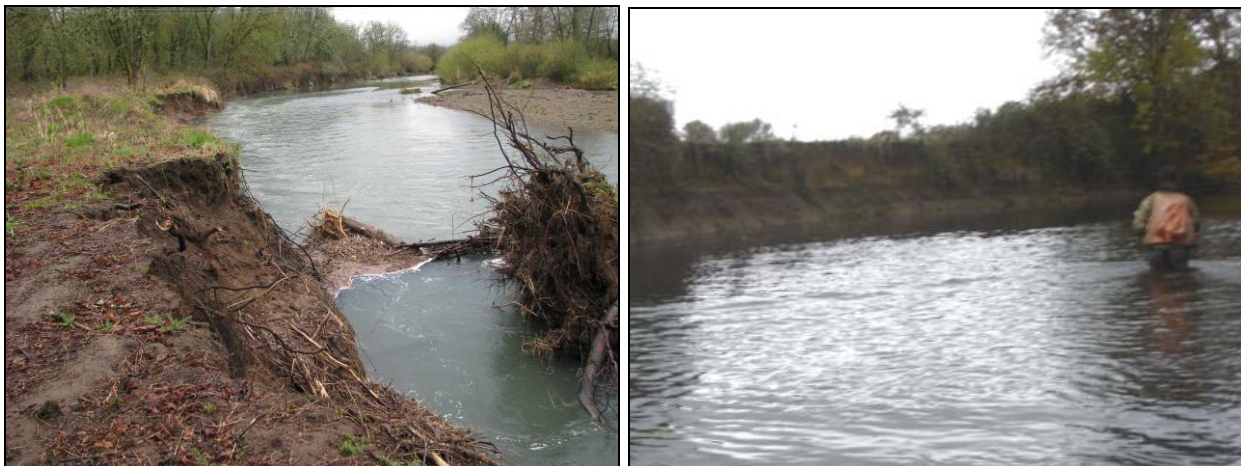
Figure 4-13. Example streambank failures in Reach 4 include the Smith property (left – photo courtesy of T. Putney) and the bank at Sta. 354+00 (right).

Bedrock and coarse bed material limit bank erosion in upstream half of Reach 4. However, streambank failures are prevalent in the downstream half of the Reach 4, primarily affecting the southern streambank. The bank erosion occurring at the Smith property exemplifies the mass wasting taking place in some portions of Reach 4 (Figure 4-13). Erosion at Sta. 354+00 and 366+00 is influenced by tight, low radius meanders. These two meanders may be influenced by the riprap bank that separates them. Sediment sources are delivery fine silts, clay, and sand material to the Calapooia River. These banks will continue to erode until an angle of repose is achieved. Based on the current vertical nature of these sites, they will continue to erode for the foreseeable future. Summary bank erosion metrics are included in table

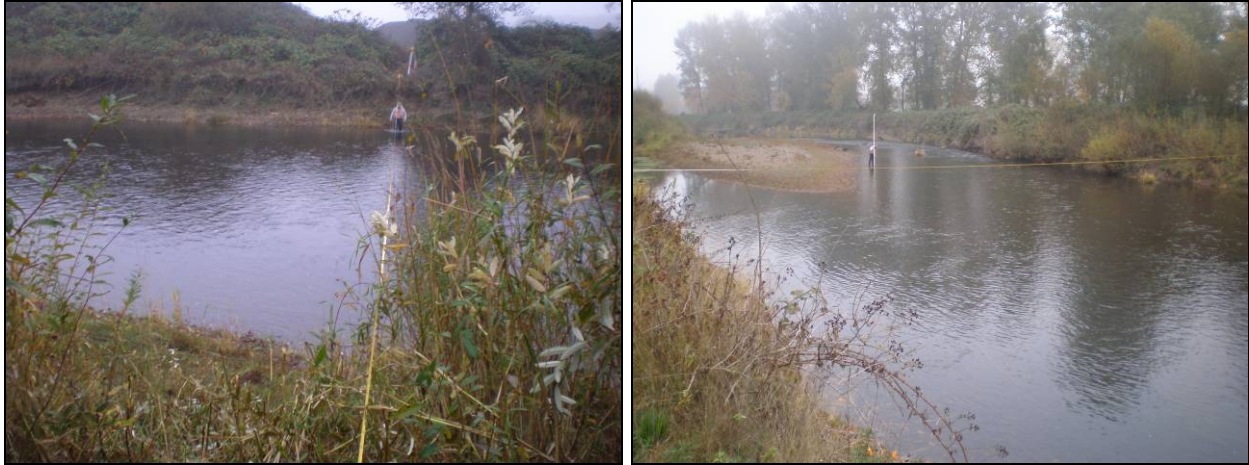
A hydraulic channel cross-section was established in Reach 4 adjacent to the Knife River gravel mining operation upstream from the Sodom Dam channel bifurcation. The cross-section was located immediately upstream of a backwater habitat unit. The channel survey was completed on October 30, 2007. The survey included a cross-section, channel profile, discharge measurement, and pebble count. Summary information from the survey is included in Figure 4-14. The photos show typical river corridor conditions in the downstream portion of Reach 4. The right bank separating the gravel extraction area is stabilized with riprap. The left streambank is not stabilized. A narrow riparian strip separates upland agricultural fields from the Calapooia River on the south bank.

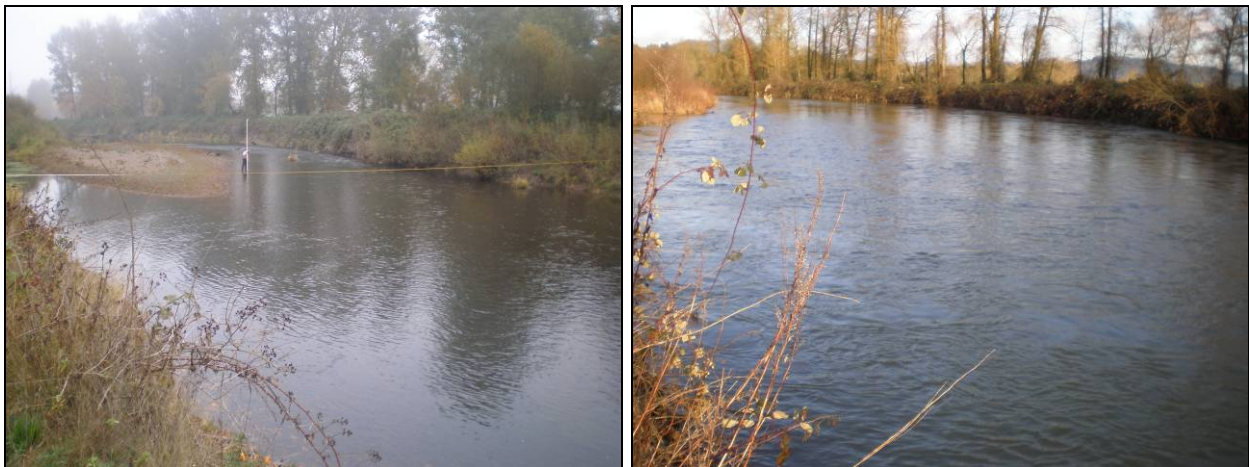
Figure 4-15. A comparison of the Calapooia River at 40 cfs (left) and approximately 1,800 cfs (right) at the Reach 4 hydraulic cross-section. The backwater habitat in the left side of the baseflow photo was completely inundated during the 1,800 cfs event. The 1,800 cfs event was approximately one-third of the estimated 2-year discharge.

Figure 4-15 shows the Reach 4 hydraulic cross-section location at the time of the survey and during elevated discharge during January 2008. A discharge measurement was not completed during the January site visit due to hazardous conditions.

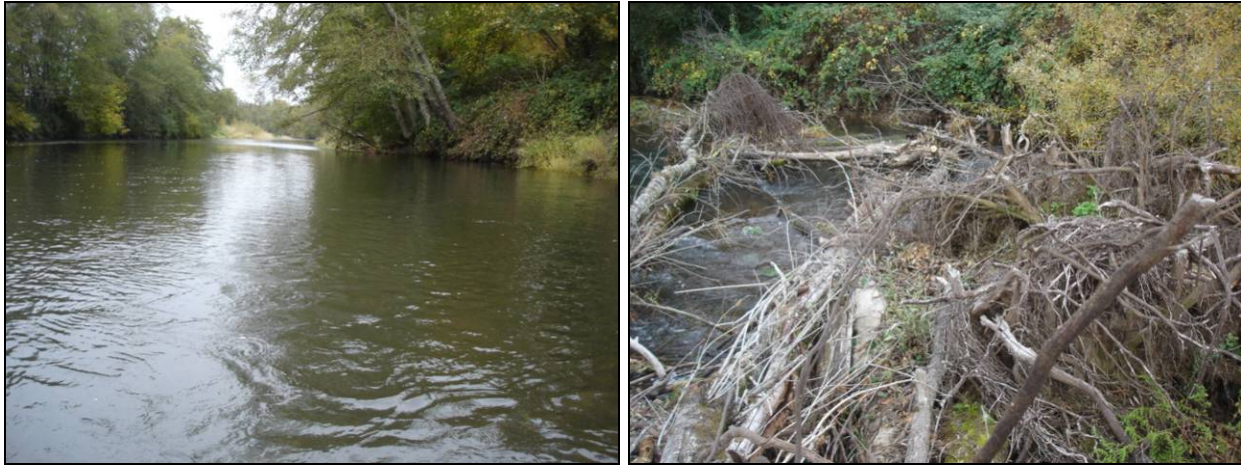
Figure 4-16. The upstream half of Reach 4 is characterized by a plane bed channel with homogenous conditions (left). Large wood accumulations in the depositional areas of Reach 4 offer cover and lower water velocities that are beneficial for juvenile fish rearing.

Fish habitat through Reach 4 varies between homogenous glide habitats in the straight sections of the channel, to diverse backwater habitats located in the depositional areas of the reach. Floodplain channels are limited in the reach due to the narrow river corridor. Large wood is prevalent in the depositional sections, creating both cover and varied hydraulics. Wood is generally lacking in the straight sections, offering an opportunity to enhance channel margin juvenile rearing habitat. Example Reach 4 habitats are shown in Figure 4-16.

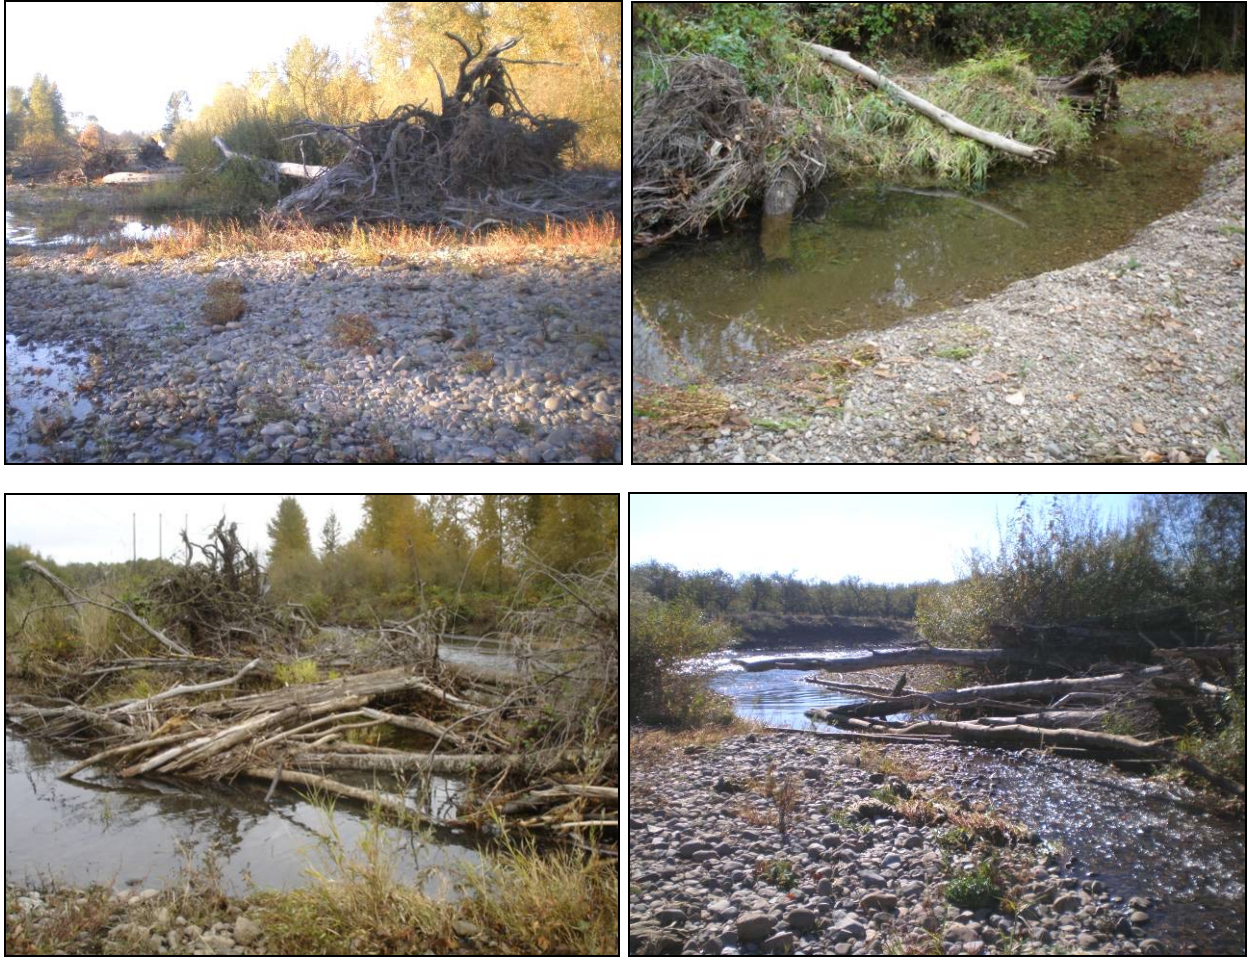
Figure 5-1. Examples of large wood in the Middle Calapooia River. Large wood influences sediment deposition patterns, focuses stream flow creating scour, provides cover for fish and wildlife, and captures additional debris.

How wood functions also depends on its location within the river corridor. Wood in the mainstem river is typically more mobile than floodplain wood as mainstem debris experiences higher velocities and shear stress. Floodplain wood experiences lower velocities and is less prone to mobilization. Vegetation can trap large wood and create rafts of debris. Vegetation may also colonize the fine sediments that typically deposit in the leeward direction of wood, and over time, vegetation anchors the wood. Figure 5-1 includes several examples of large wood in the Calapooia River. Photos illustrate the role of wood in forming channel morphology, providing fish habitat, and influencing channel hydraulics.

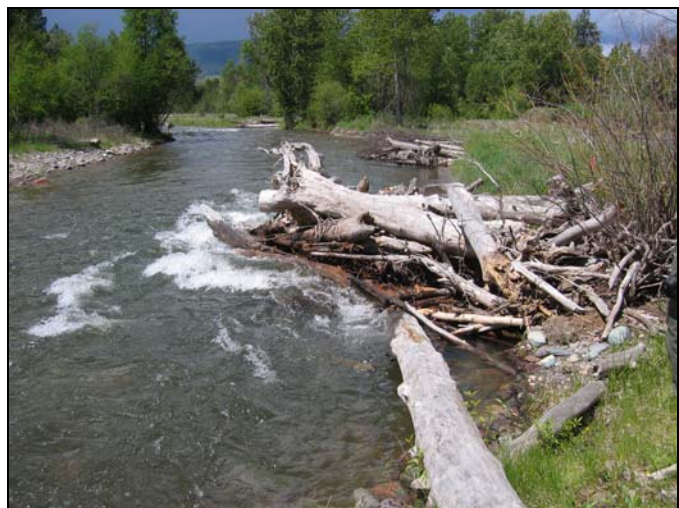
Figure 5-2. An ELJ constructed on the Jocko River in western Montana following two run-off events.

Engineered log jams (ELJs) are installed for bank stabilization, flow deflection, and mainstem river habitat. ELJs will be completed on the mainstem river and will provide complex cover for juvenile and adult fish. ELJs will be constructed with approximately 10 to 15 trees including rootwads, whole trees, and tree tops (Figure 5-2). To provide structure ballast, approximately 10 yd³ of large rock will be placed within each structure. The ELJs are also backfilled with native alluvium to reduce the potential for intra-structure piping. Rootwad sizes will average 3 ft to 4 ft in fan diameters and have minimum stem lengths of 30 ft. ELJs span from the predicted scour depth to above the bankfull channel elevation to provide a range of fish habitat and structure stability.

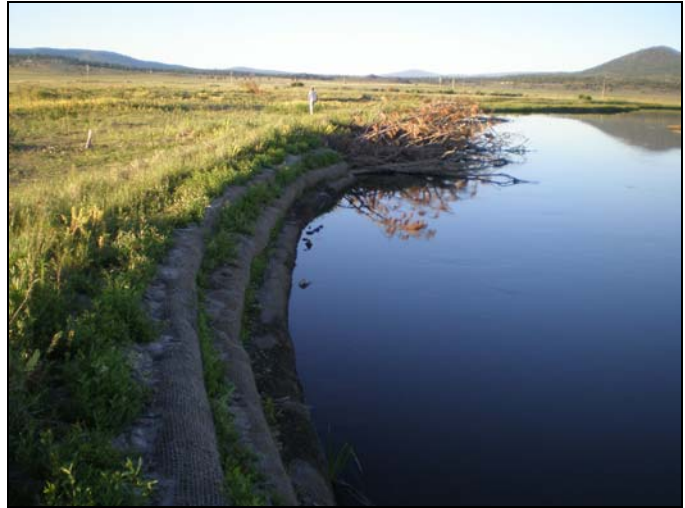
Figure 5-3. A vegetated soil lift following spring runoff and at the start of the growing season on the Sprague River.

Vegetated soil lifts is a bioengineering technique that combines layers of dormant willow cuttings and/or containerized willows with fabric-wrapped soil to revegetate and stabilize stream banks and slopes (Figure 5-3). Vegetated soil lifts are proposed for stabilizing bank erosion sites where a new bank face will be constructed. To construct a vegetated soil lift, a coarse cobble toe is first established. The first soil lift incorporates a high density coir log backed with soil and wrapped within two layers of biodegradable coconut (coir) fiber fabric. Dormant willow cuttings or containerized plants and a native seed mix are placed on each lift. The cuttings or plants are placed horizontally to extend into the stream channel. Cuttings should be placed so that only $\frac{1}{4}$ of the cutting is exposed. A two to three-inch layer of top soil is placed between each lift to reduce air pockets and provide rooting medium for the willow cuttings. The coir fabric holds the soil in place while vegetation becomes established in the relatively high stress land/water interface. Vegetated soil lifts will provide near-term bank protection until planted vegetation becomes established.

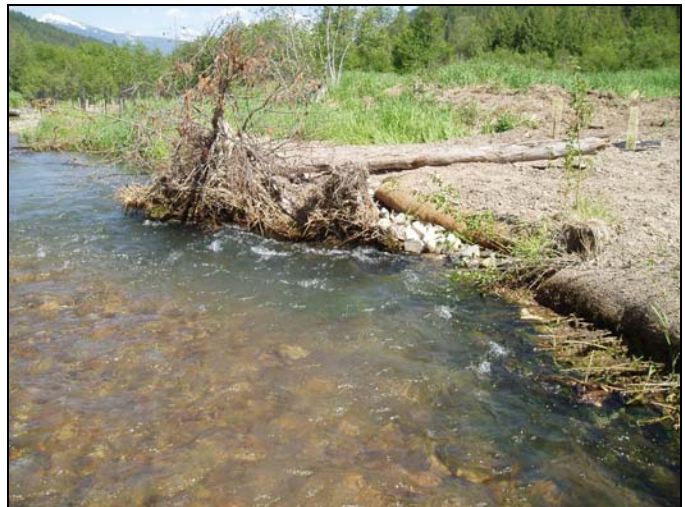
Figure 5-4. A large wood habitat composite with adjacent soil lift on Pilgrim Creek in western Montana.

Large wood will be used to enhance floodplain channels and backwater habitats. Large wood will be installed both singularly and in aggregate. These structures will be smaller than ELJs and require less material (Figure 5-4). In general, each structure will include at two rootwads and several logs for ballast. Large wood structures may either be anchored in the ground, ballasted with large rock, pinned together, or longer tree pieces will be placed in the riparian zone angled towards the channel.
