Effectiveness Monitoring Progress Report
South Santiam, North Santiam and Calapooia Watershed Councils
2010

Eric Andersen, Regional Monitoring Coordinator

4431 Highway 20, Sweet Home OR. 97386

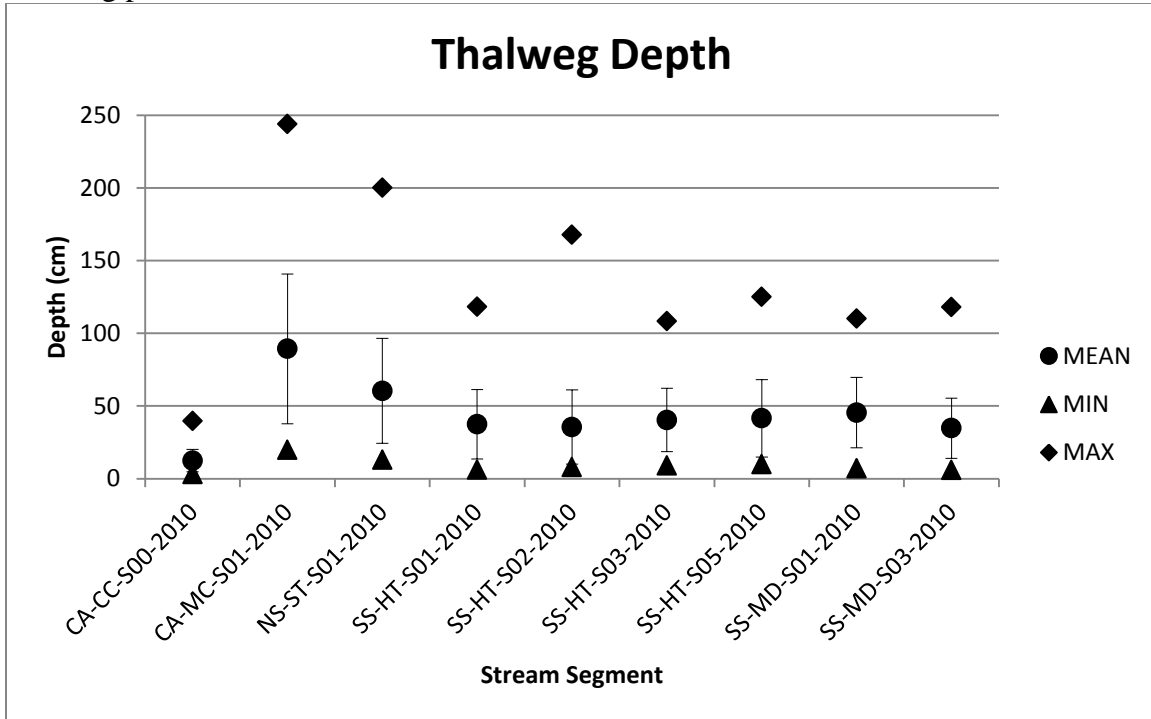
Thalweg profile all sites:

Stream segment CA-MR-S01-2010 had the deepest (mean=89cm) and most variable (stdev=52) thalweg profile. This was expected as it is the largest river in the survey and an outlier within the stream segments measured for thalweg. Segment NS-ST-S01-2010 had the second deepest (mean=60cm) profile and variable thalweg (stdev= 36) profile. Segment CA-CC-S00-2010 is a control reach and had the shallowest (mean=12cm) and the least variable (stdev=8cm) thalweg profile.

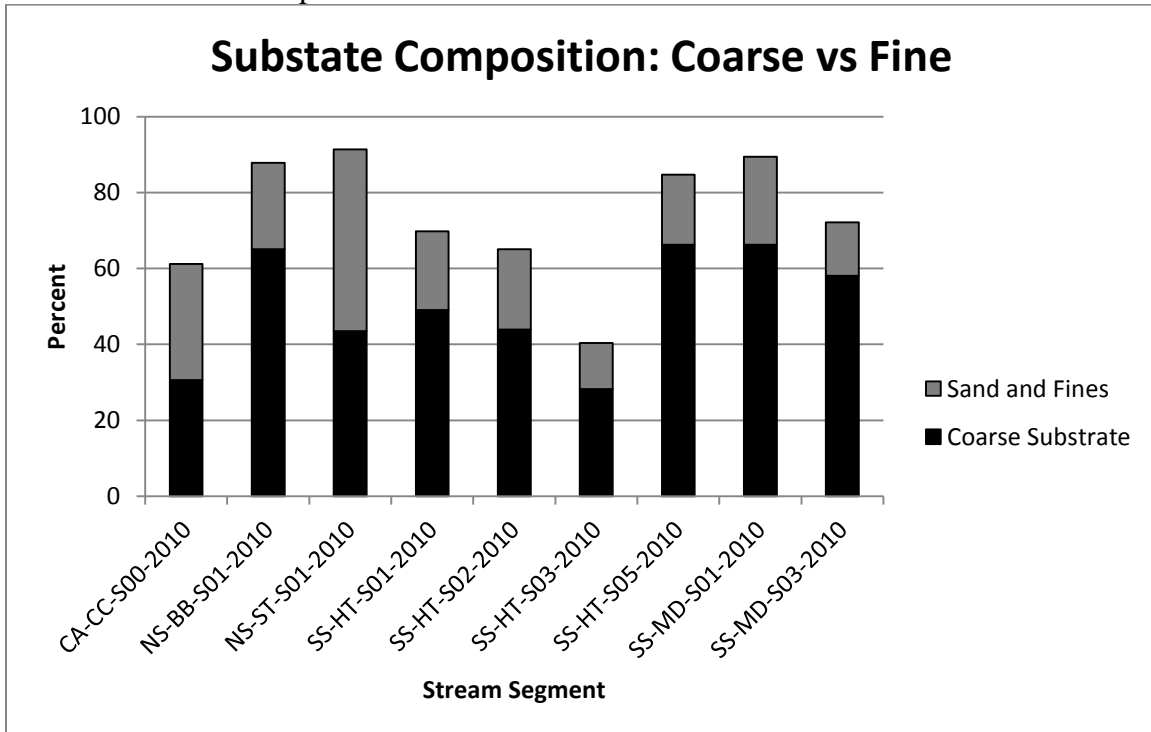
Overall Substrate Composition:

Stream segments SS-HT-S05-2010 and SS-MD-S01-2010 had the highest percentage of substrate composed of cobble and coarse gravel (66.3%). Stream segment NS-ST-S01-2010 had the highest percentage of sand and fines (47.8%). Stream segment SS-HT-S03-2010 had the lowest percentage (12.2%) of fines and sands composing the reach. The embeddedness of substrate ranged from 21% to 57% for all reaches surveyed.

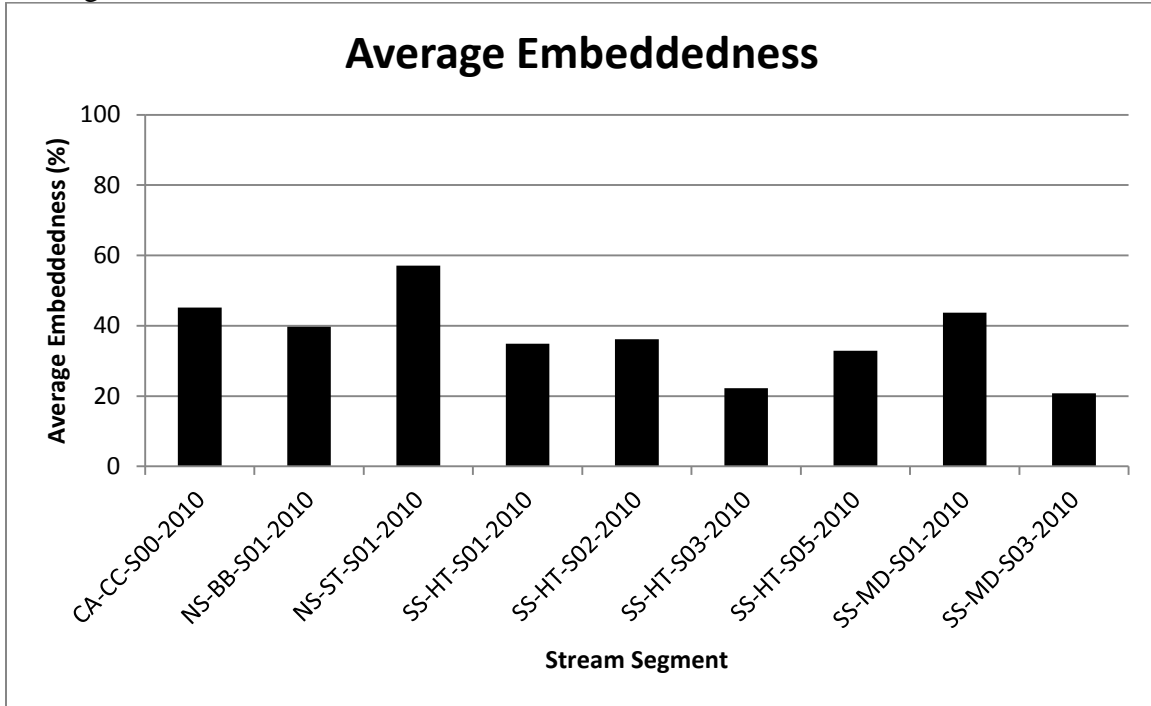
Average embeddedness of substrate:

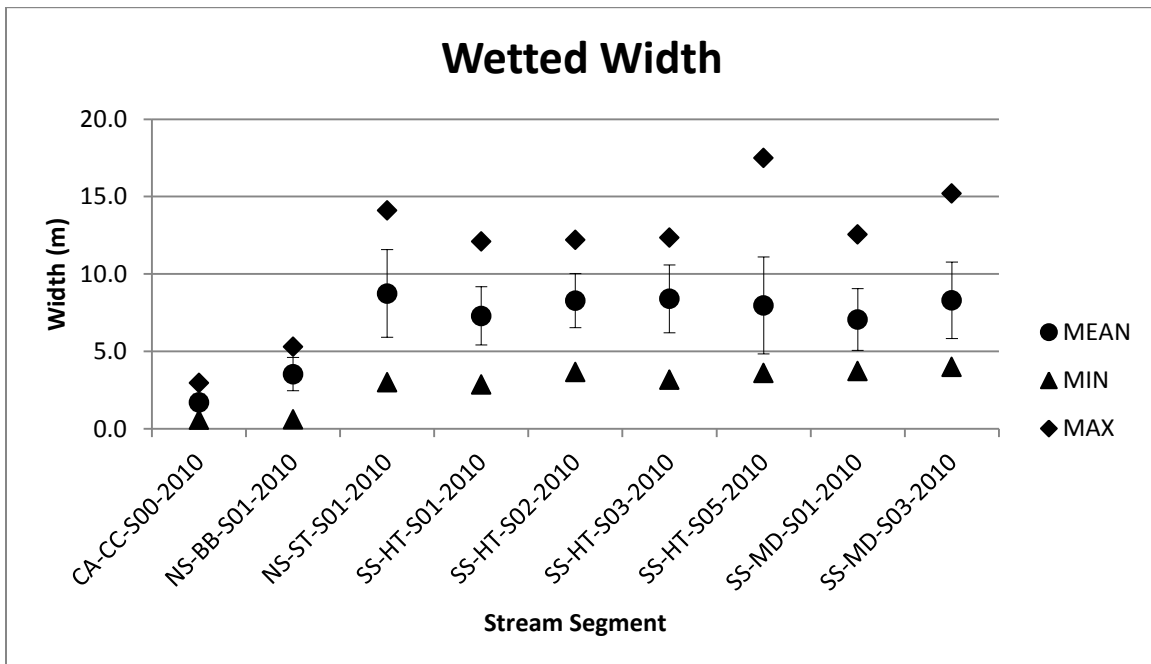
Wetted width all sites:

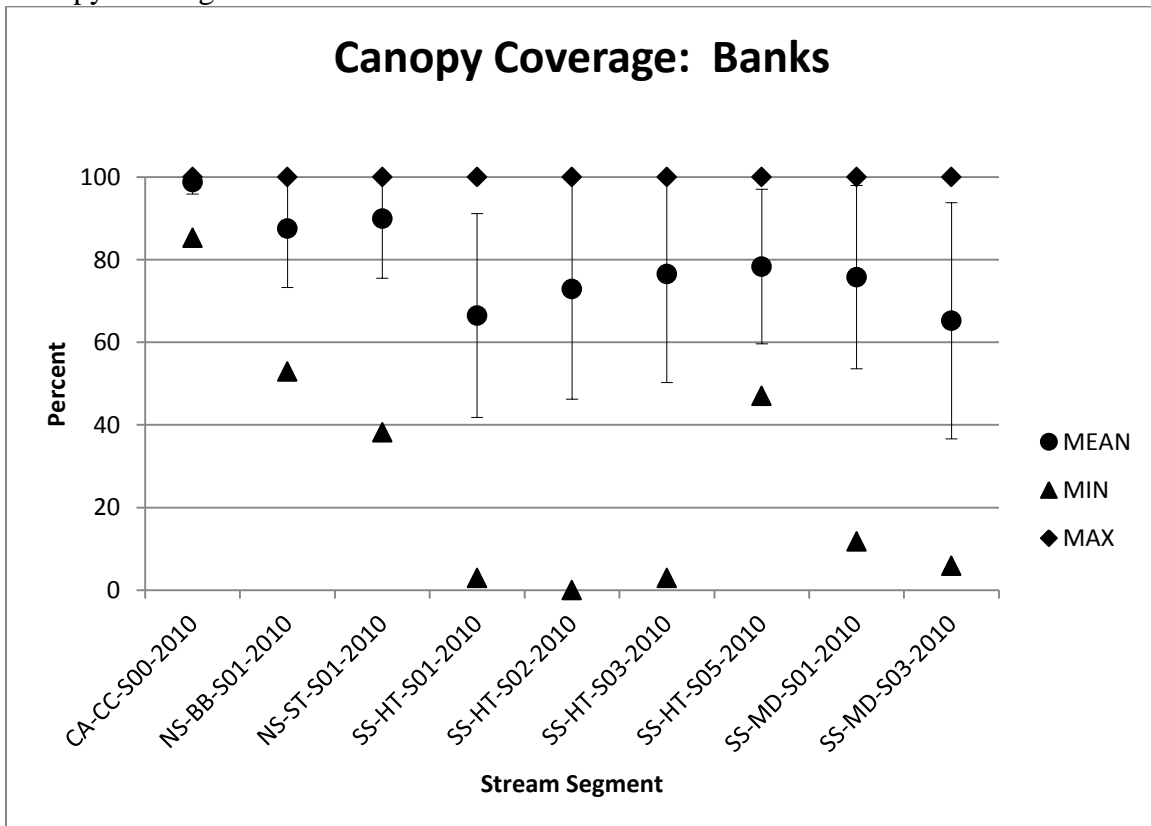
Canopy coverage of river banks:

Canopy coverage was highly variable overall, at stream banks and in mid-channel for all sites except CA-CC-S00-2010. Mean overall canopy cover was $\geq 51\%$ in all stream segments. Mean canopy cover at the banks was $\geq 65\%$ at all segments. Mean canopy cover at mid-channel was $\geq 30\%$ at all segments.

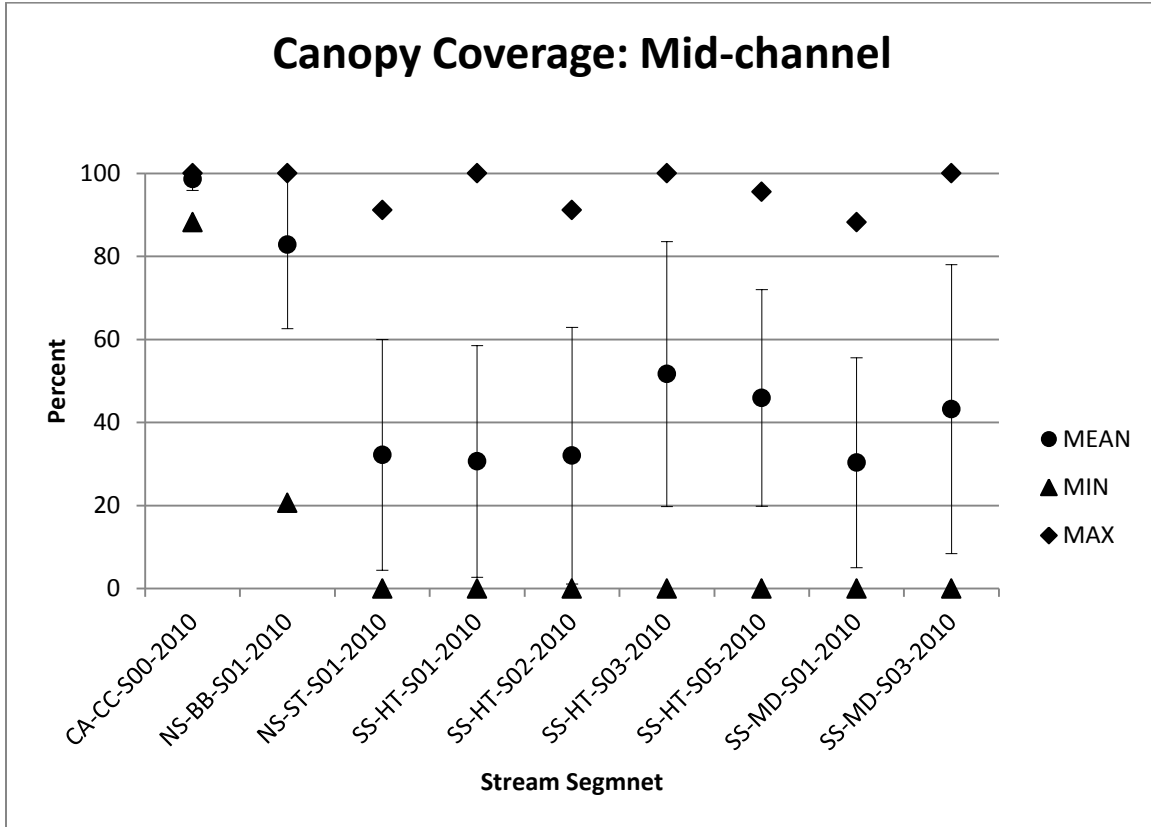
Canopy coverage at streams mid channel:
