# CALAPOOIA RIVER GEOMORPHIC ASSESSMENT

## SODOM DAM BIFURCATION TO BUTTE CREEK CONFLUENCE

**DRAFT** May 2009

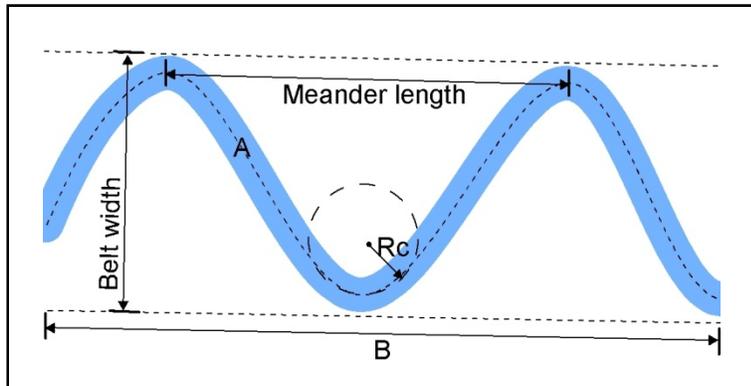
**Figure 1-1.** Illustration of plan form metrics (Adapted from Rosgen 1996).  $R_c$  denotes the radius of curvature. Meander length is the distance between two bends in the river. Belt width is the width of the river corridor. Sinuosity is the channel length (dashed line A) divided by the straight line length of the valley bottom (line B).

Following digitization of the Calapooia River, meanders for each year were identified, and lines were digitized between each meander's point of maximum curvature (Figure 1-1). Beltwidth extents and curvature radii were also digitized at each of these points.

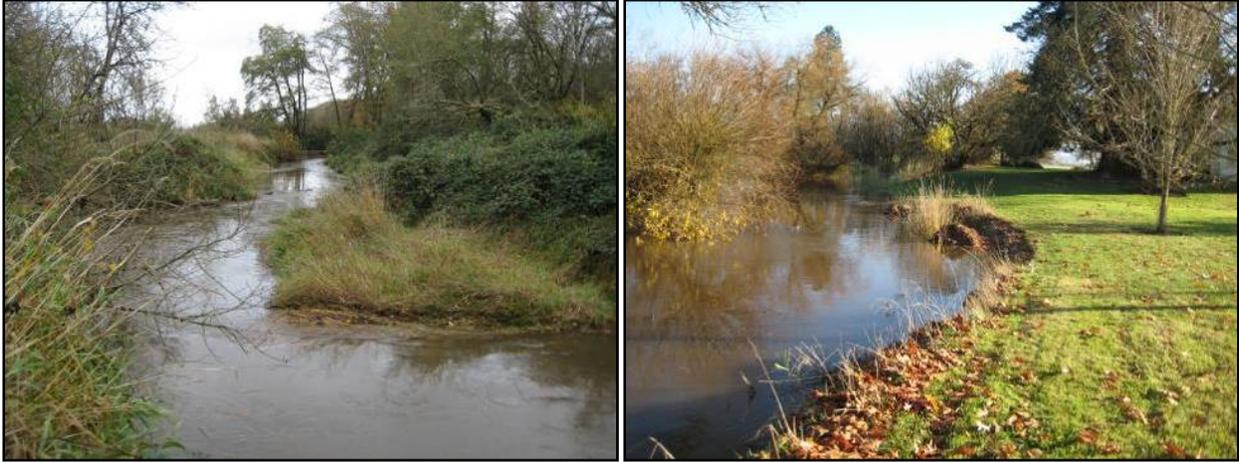
**Figure 3-1.** Examples of riparian conditions in Reach 1 (left) and Reach 2 (right) of the project reach. Native and invasive species characterize the riparian community through the project reaches. Residential and agricultural developments have replaced native vegetation assemblages.

Notes and maps from the original land surveys conducted in the 1850s indicate that the Calapooia River was bordered by a continuous corridor of trees. Because of repeated burning of the valley floor by Native Americans during the previous centuries, vegetation beyond this corridor of trees was mostly native prairie or oak savanna. An examination of natural and human features that currently occupy land within this historical corridor of trees indicates that the combined percentage of trees and water features is only about 50% of what it was in the 1850s. About one-half of the land along the Calapooia River that supported trees in the 1850s has since been converted to grass seed fields and other development. Remaining patches of older trees are mostly in low-lying areas that are too wet for farming (Figure 3-1). Older stands of trees are

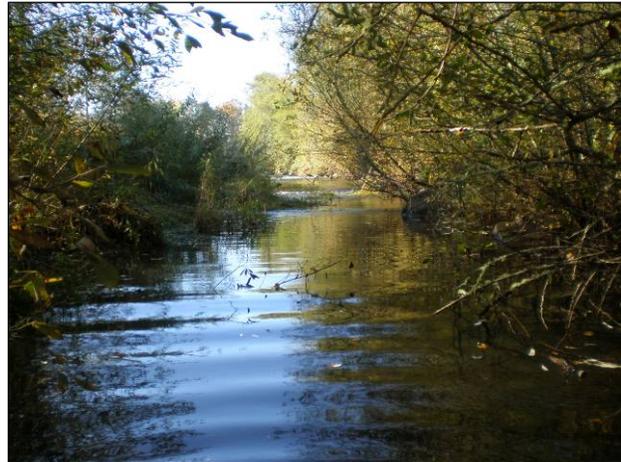
**Figure 3-3.** An example of a floodplain channel that is inundated over a range of mainstem stages. These habitats provide off-channel habitat for fish and amphibians.

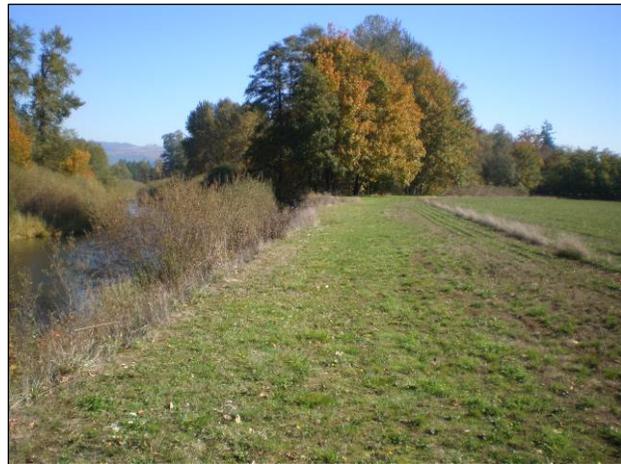
**Figure 3-6.** A grass seed field paralleling the Calapooia River. The site is characterized by a minimal riparian buffer separating the river from agricultural production.

Grass seed farming is an important agricultural occupation in the Calapooia River watershed (Figure 3-6). Improving agricultural practices would address nitrogen fertilizer runoff to the river. Compared to cultivated riparian zones, non-cultivated riparian zones are very effective at removing nitrogen from subsurface water draining into a stream. However, due to flow patterns and the speed of surface runoff, while retaining riparian vegetation is generally beneficial to streams, the benefits do not include mitigating nitrogen runoff. The most effective means to control nitrogen runoff from grass seed fields begin with applying only the minimum amount of fertilizer needed to grow a crop and that the timing of the fertilizer coincide with periods of drier weather.

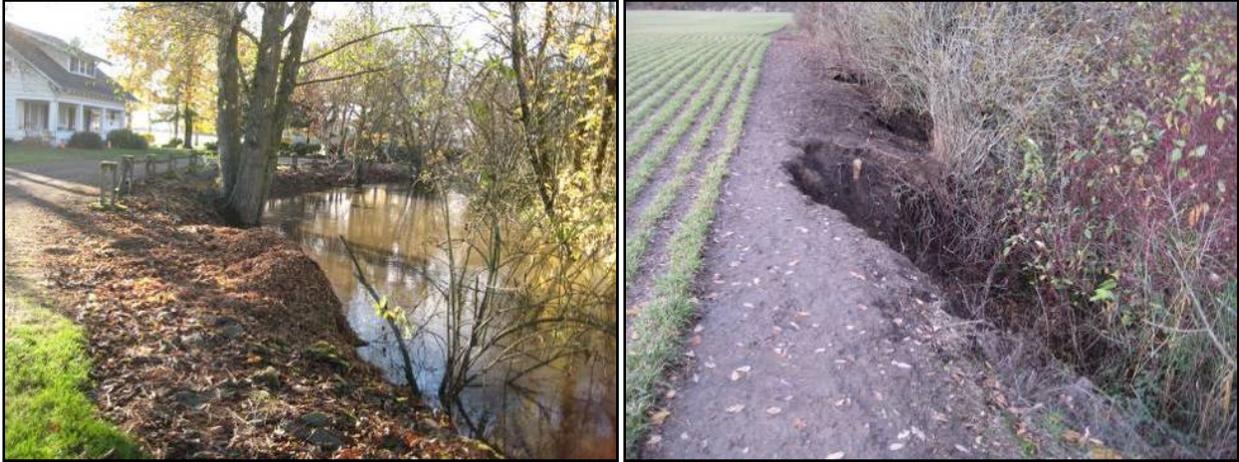
**Figure 3-7.** Working with landowners to maintain riparian vegetation buffers between residences (left) and agricultural fields (right) would reduce sediment loading to the Calapooia River and slow property loss.

Where rivers have been treated in such a way, conflicts among landowners and declines in fish habitat invariably occur (Figure 3-7). In addition, stopping the meandering on one segment of river usually causes an upstream or downstream increase in meandering and erosion, often

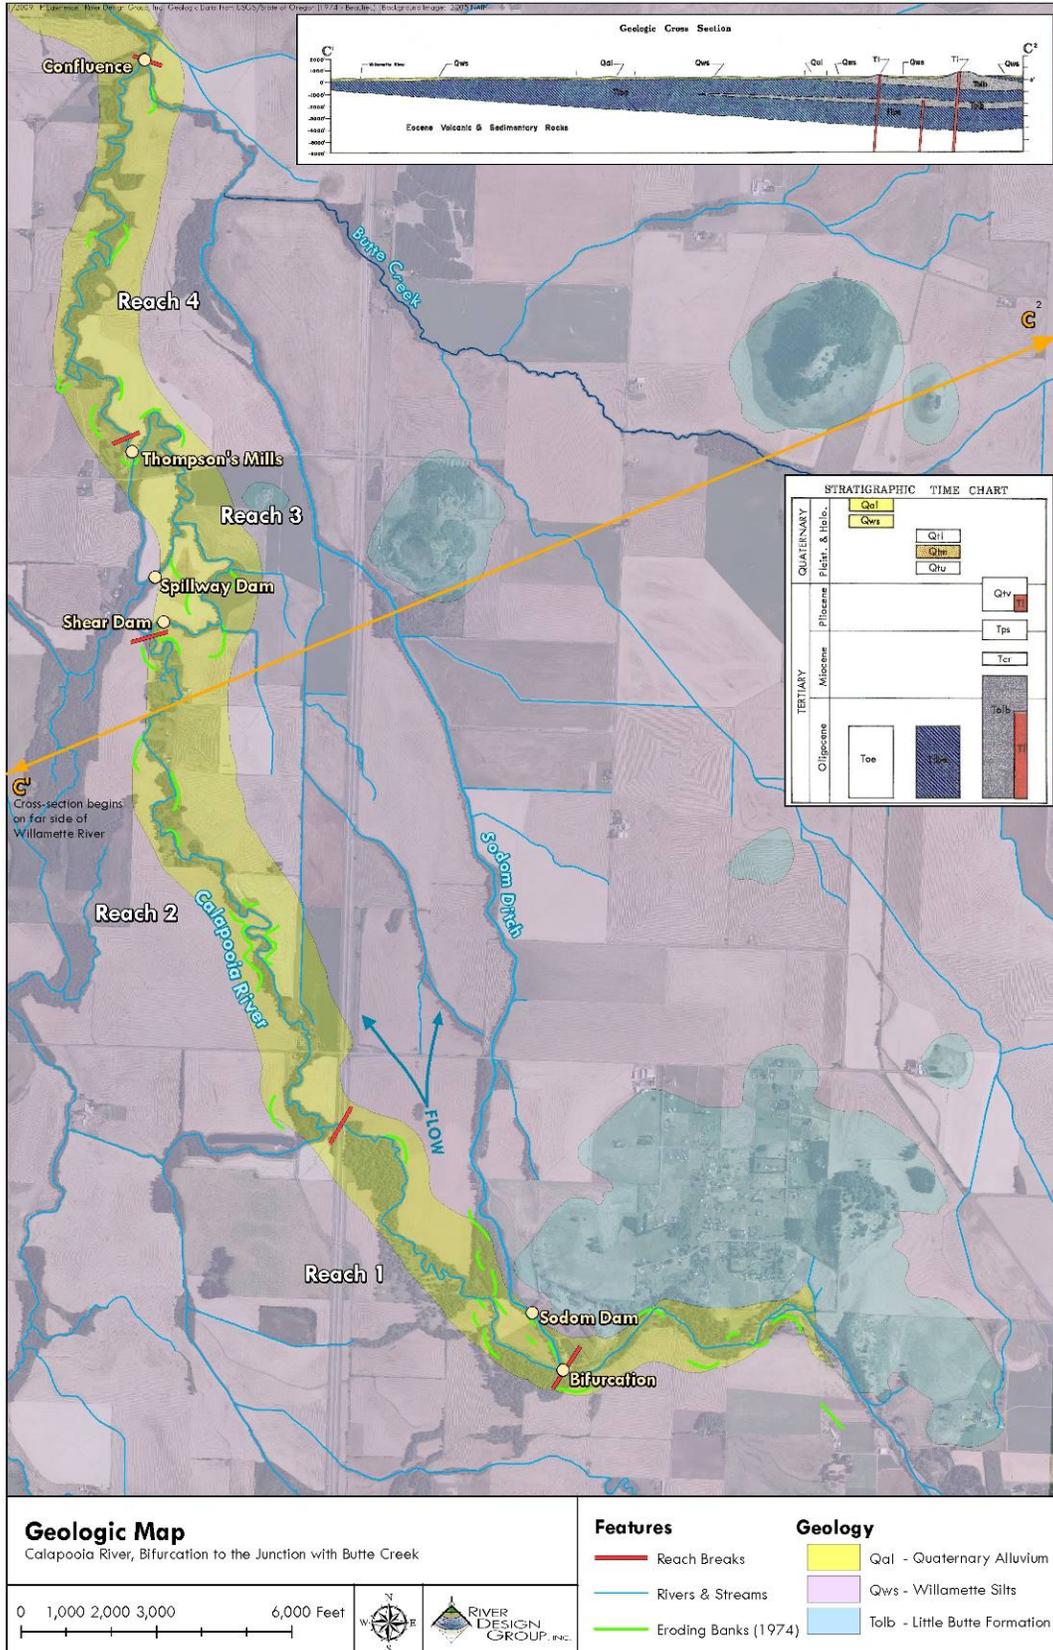
Figure 4-2. Calapooia River project area geology.

The geology of the Calapooia River project area is comprised of an underlying formation of Tertiary period pyroclastic rocks and balsatic flows overlaid by Quaternary alluvium and Willamette silts (Beaulieu 1974). The Calapooia River channel migration zone is dominated by alluvium derived from the Calapooia River (Figure 4-2). The alluvium, similar to other tributaries in the Willamette Valley, ranges in depth but is typically tens of feet thick and comprised of gravel, sand and silt. Thinner veneers of silt and clay are also common.

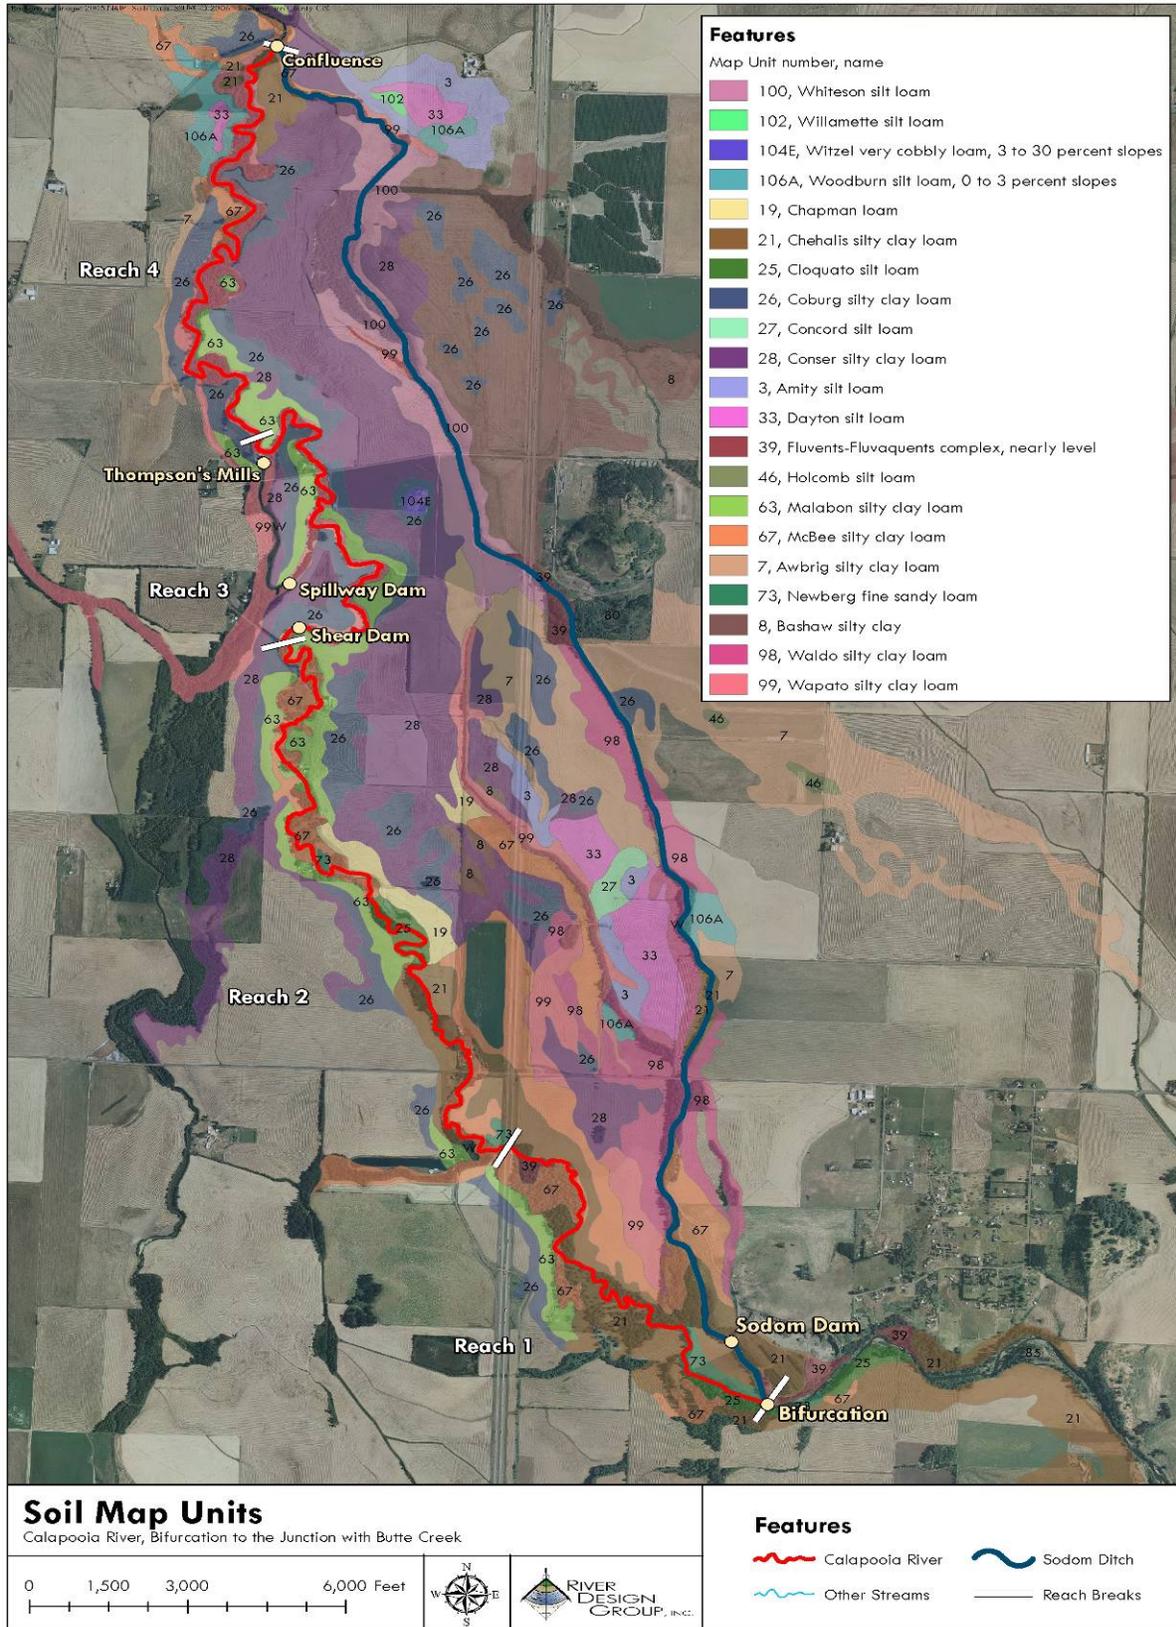
Figure 4-3. Soil map units in the project area.

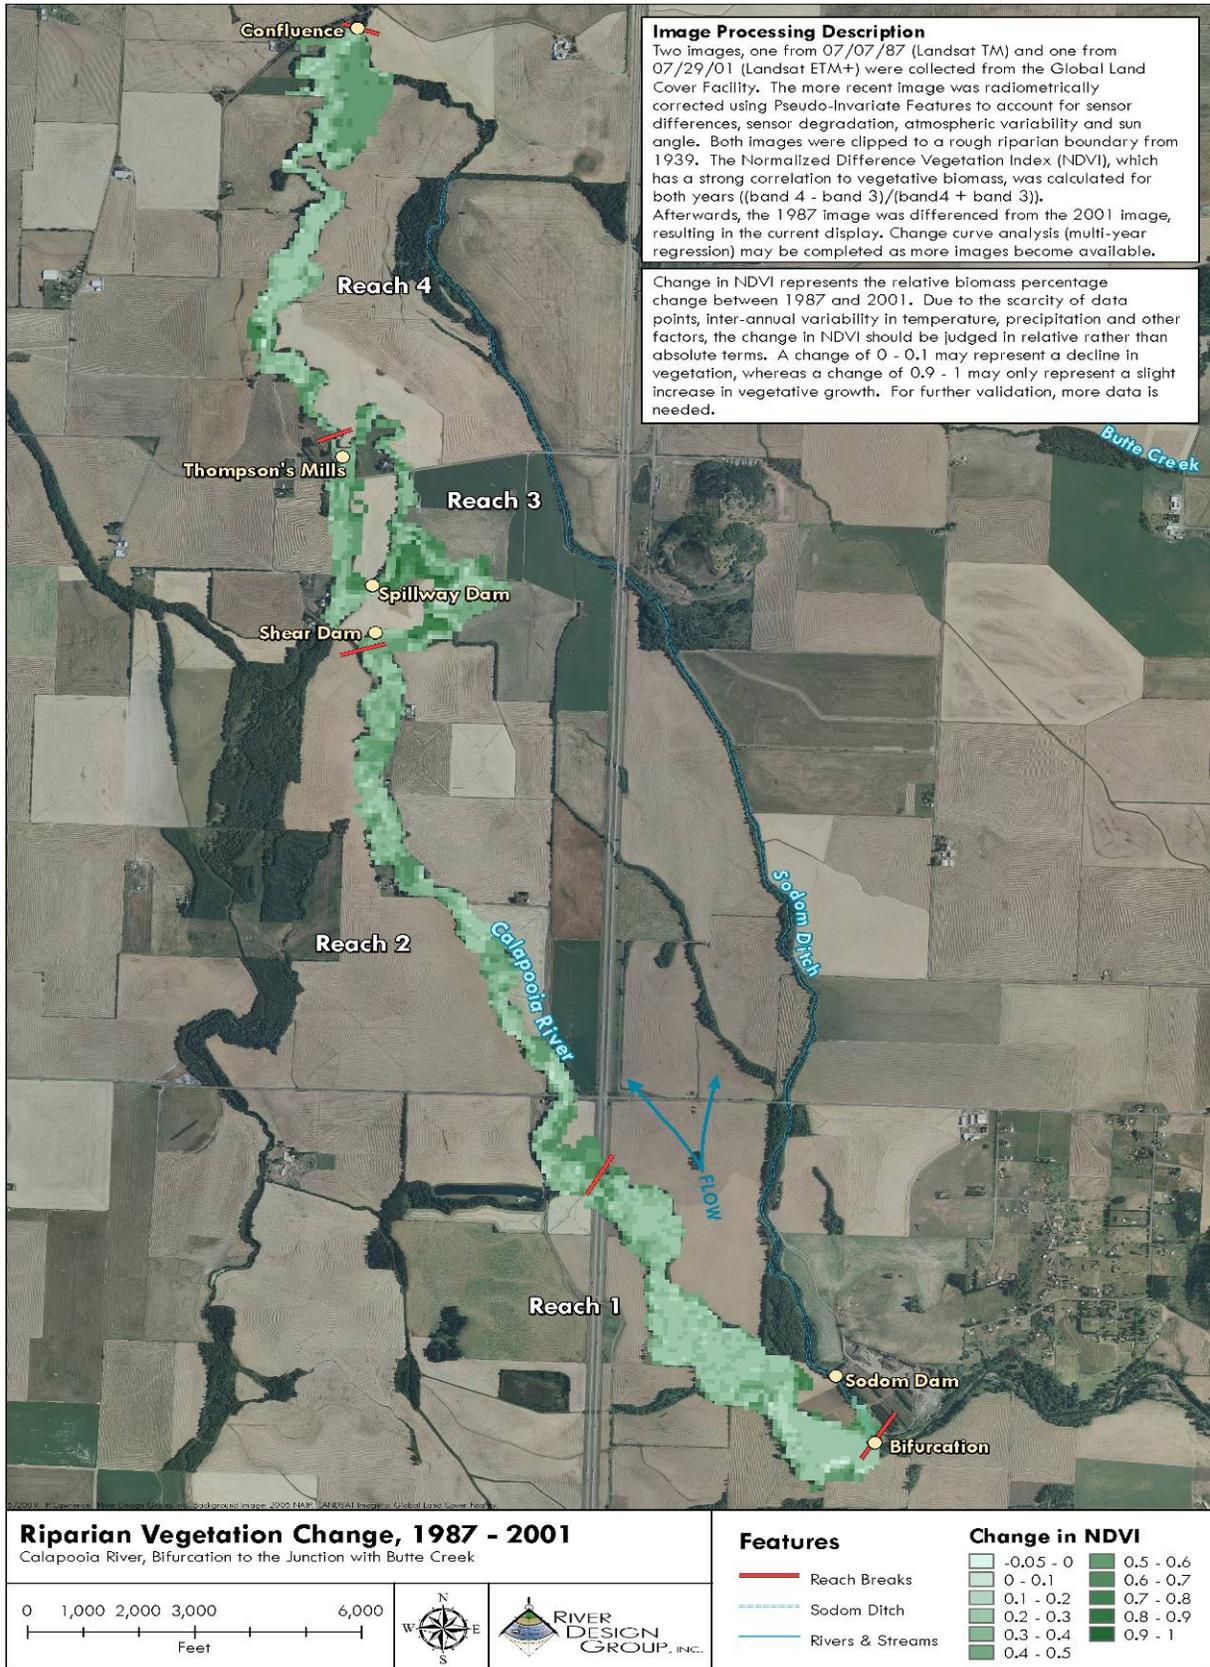
Figure 4-4. Riparian vegetation change from 1987 to 2001 in the project area.

Review of historical air photos suggests that the riparian zone narrowed over time as the Calapooia River corridor was developed for agriculture. While the riparian community has experienced substantial reduction since 1936, much of the floodplain was already developed by that point. In general, native riparian vegetation has been displaced by agricultural fields. Native vegetation displacement has included both full removal and thinning of the riparian canopy. Decreased riparian density may be related to loss of canopy trees, grazing of floodplain areas, or displacement of canopy-forming species by invasive vegetation such as Himalayan blackberry and Scotch broom. The historical channel comparison map highlights several areas that have experienced riparian vegetation conversion.

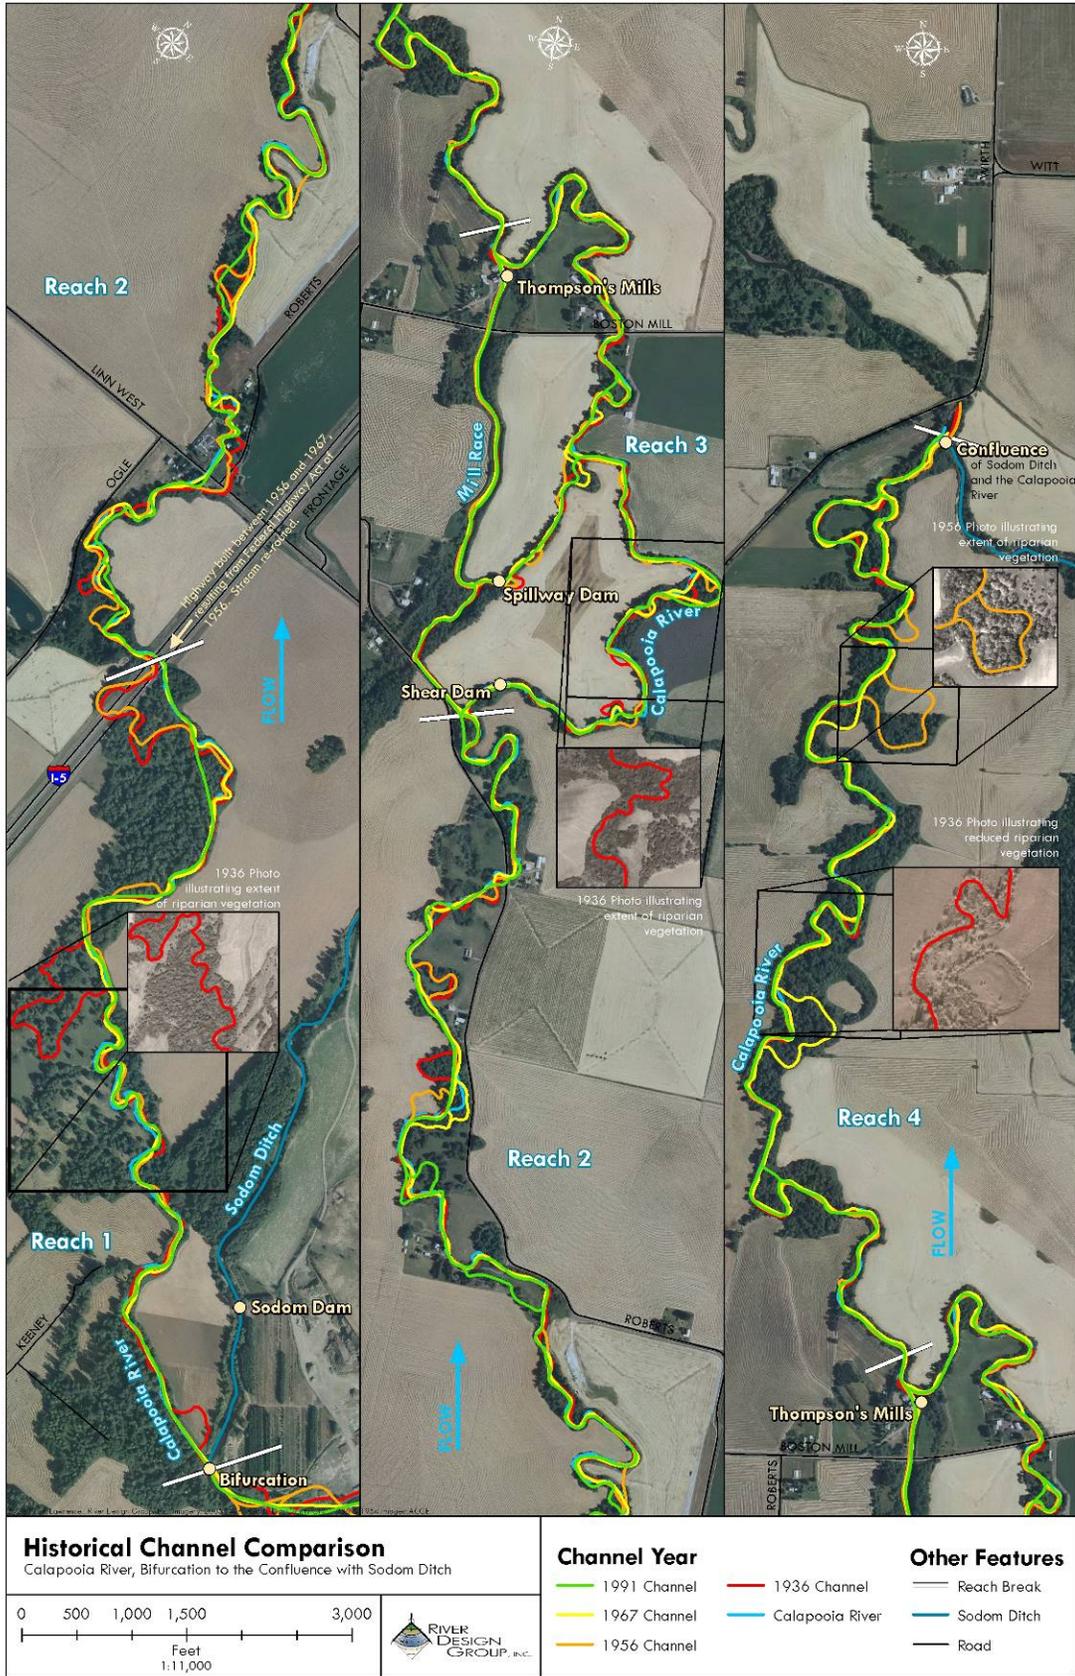
Figure 4-6. A comparison of the historical locations of the Calapooia River and Sodom Ditch since 1936.

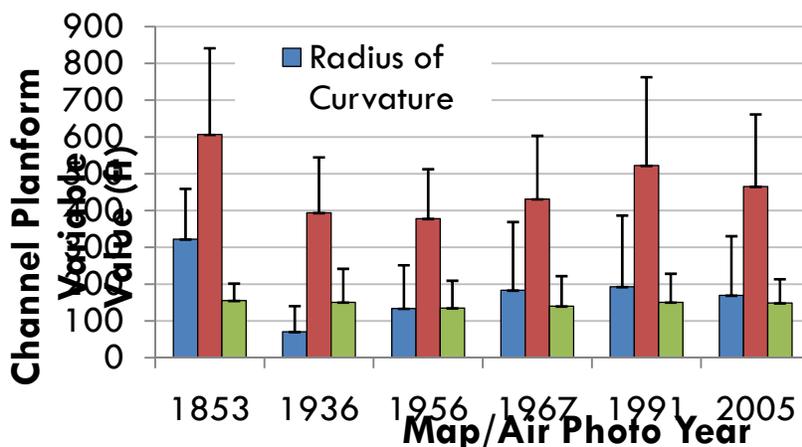
**Figure 4-7.** A comparison of the radius of curvature, meander length, and belt width for Reach 1 over the map/air photo history.

Reach 1 morphological changes are similar to trends observed throughout the project area. Average radius of curvature and average meander length increased 141% and 18%, respectively from 1936 to 2005 (Table 4-3). The increase in the radius of curvature is the greatest change of the four reaches. In Reach 1, belt width has been fairly consistent through time, exhibiting only a 1percent decrease over the 70-year period of analysis. Sinuosity, however, has decreased 27 percent, representing the greatest change in sinuosity of the four reaches. These results are due largely to two channel oxbow meanders that were present in 1936 and disconnected from the primary channel by 1956 (upstream site – STA 60+00) and 1967 (downstream site (STA 87+00)). The upstream meander cut-off may have been a natural channel avulsion as land uses did not change in the vicinity of the channel change. The oxbow meander occurs on a middle terrace feature, approximately 3 ft above the present base elevation of the Calapooia River. The downstream site was modified for the construction of Interstate 5 completed in 1966 (Kirchmeier 1989). The straightening of the Calapooia River channel at Interstate-5 truncated two meanders and reduced the channel length by several hundred feet. Similar to the upstream meander oxbow, the vertical elevation difference between the bed of the oxbow meander and present channel ranges from 3 ft to 5 ft, suggesting the degree of channel bed degradation that has occurred since 1966 on this section of the Calapooia River. These sizeable avulsions increased the river's energy gradient. Figure 4-7 includes a graphical comparison of the channel planform variables descriptive statistics. Figure 4-8 provides a comparison of Reach 1 over the photo record.

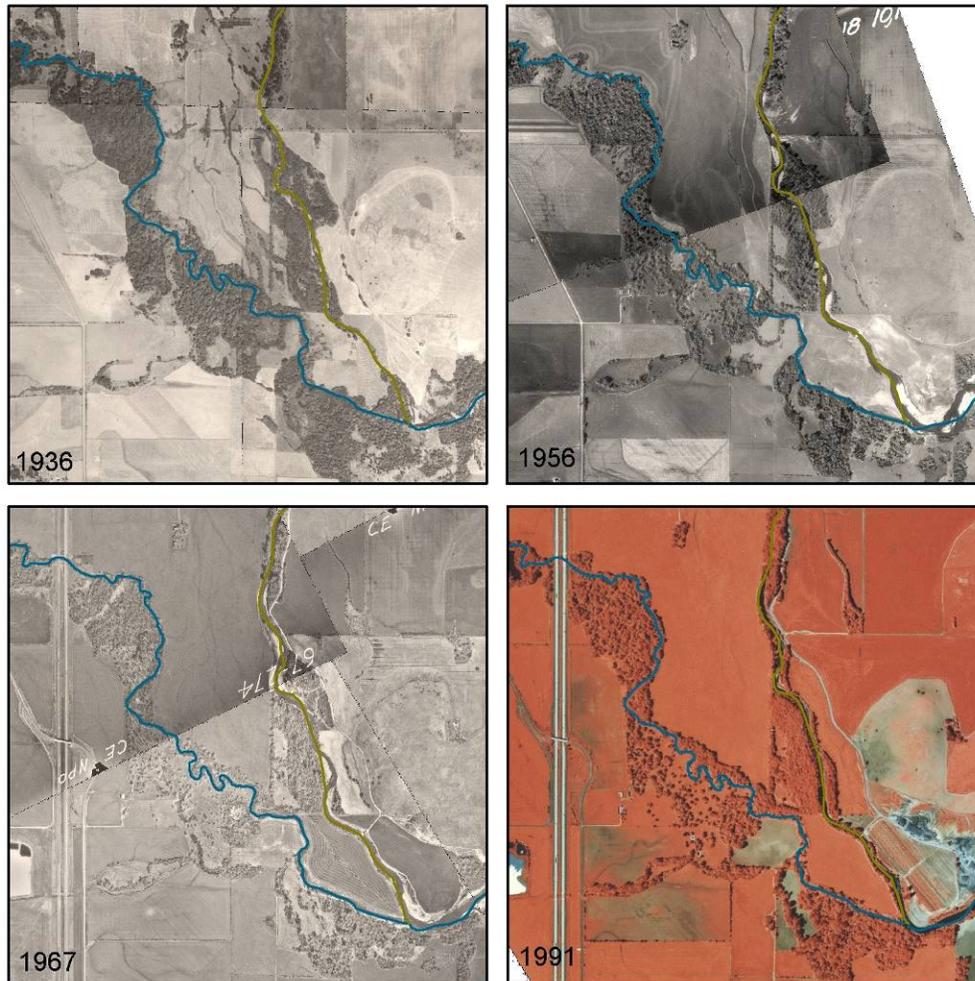
**Figure 4-8.** Historical photograph time series for Reach 1. Current channel alignments for the Calapooia River and the Sodom Ditch are shown in blue and brown, respectively. A loss of riparian vegetation and widening of the Sodom Ditch are evident over time.

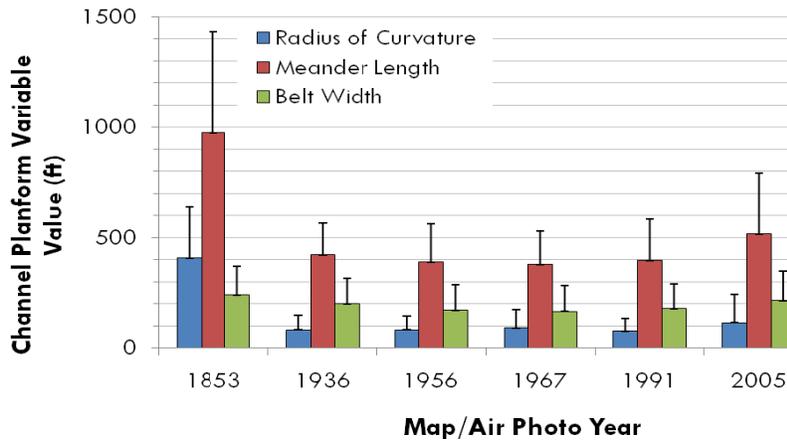
**Figure 4-9.** A comparison of the radius of curvature, meander length, and belt width for Reach 2 over the map/air photo history.

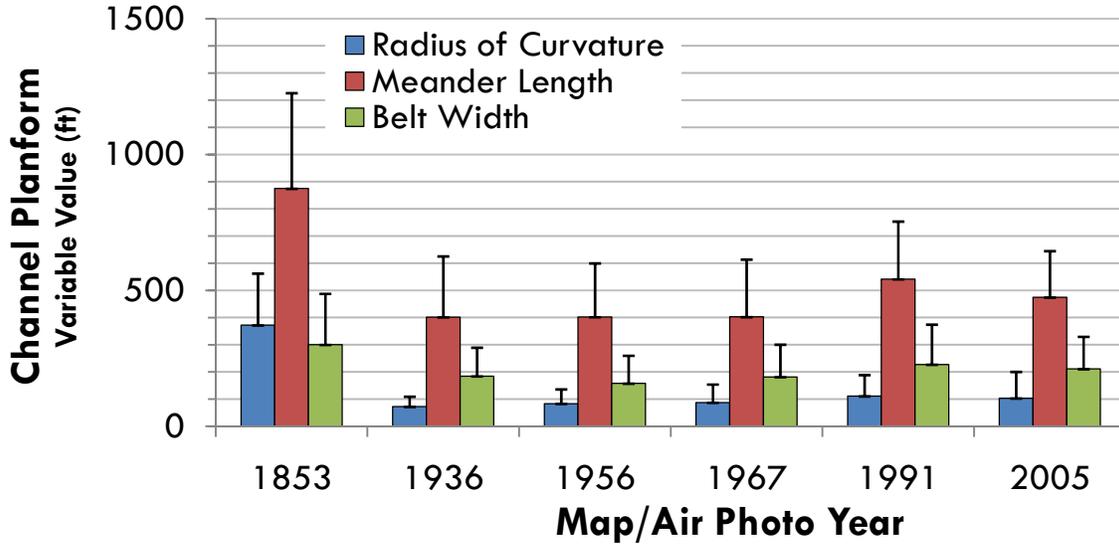
**Figure 4-10.** A comparison of the radius of curvature, meander length, and belt width for Reach 3 over the map/air photo history.

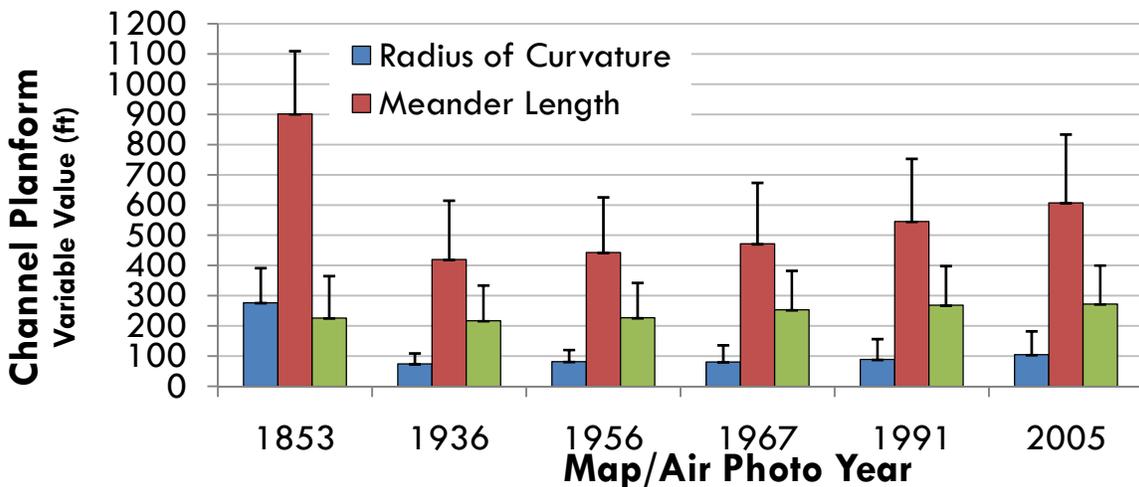
**Figure 4-11.** A comparison of the radius of curvature, meander length, and belt width for Reach 4 over the map/air photo history.

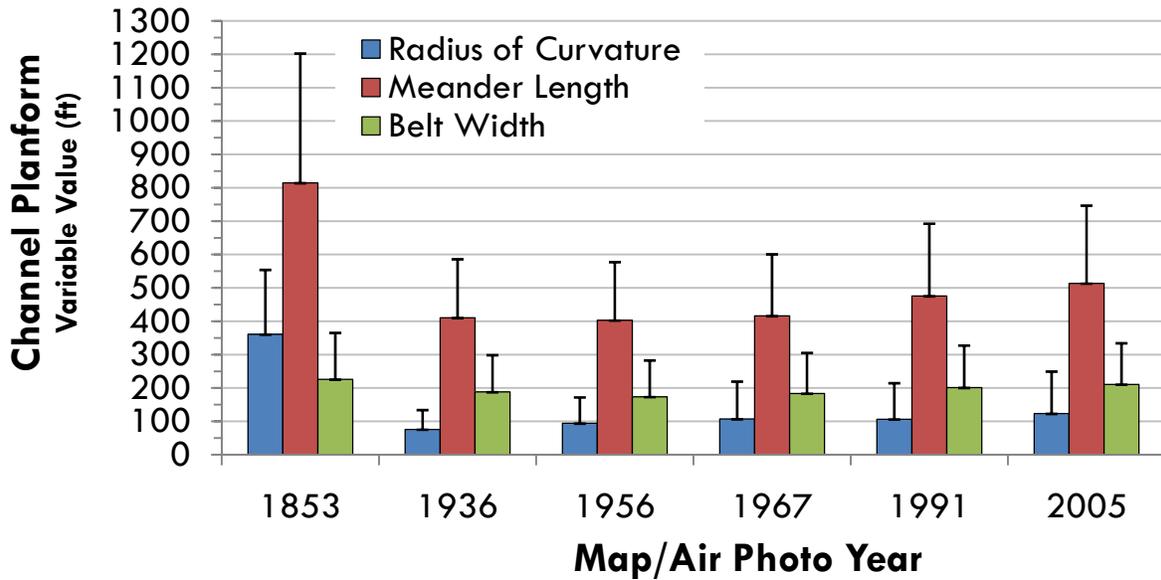
**Figure 4-12.** A comparison of the radius of curvature, meander length, and belt width for the Calapooia River project area over the map/air photo history.

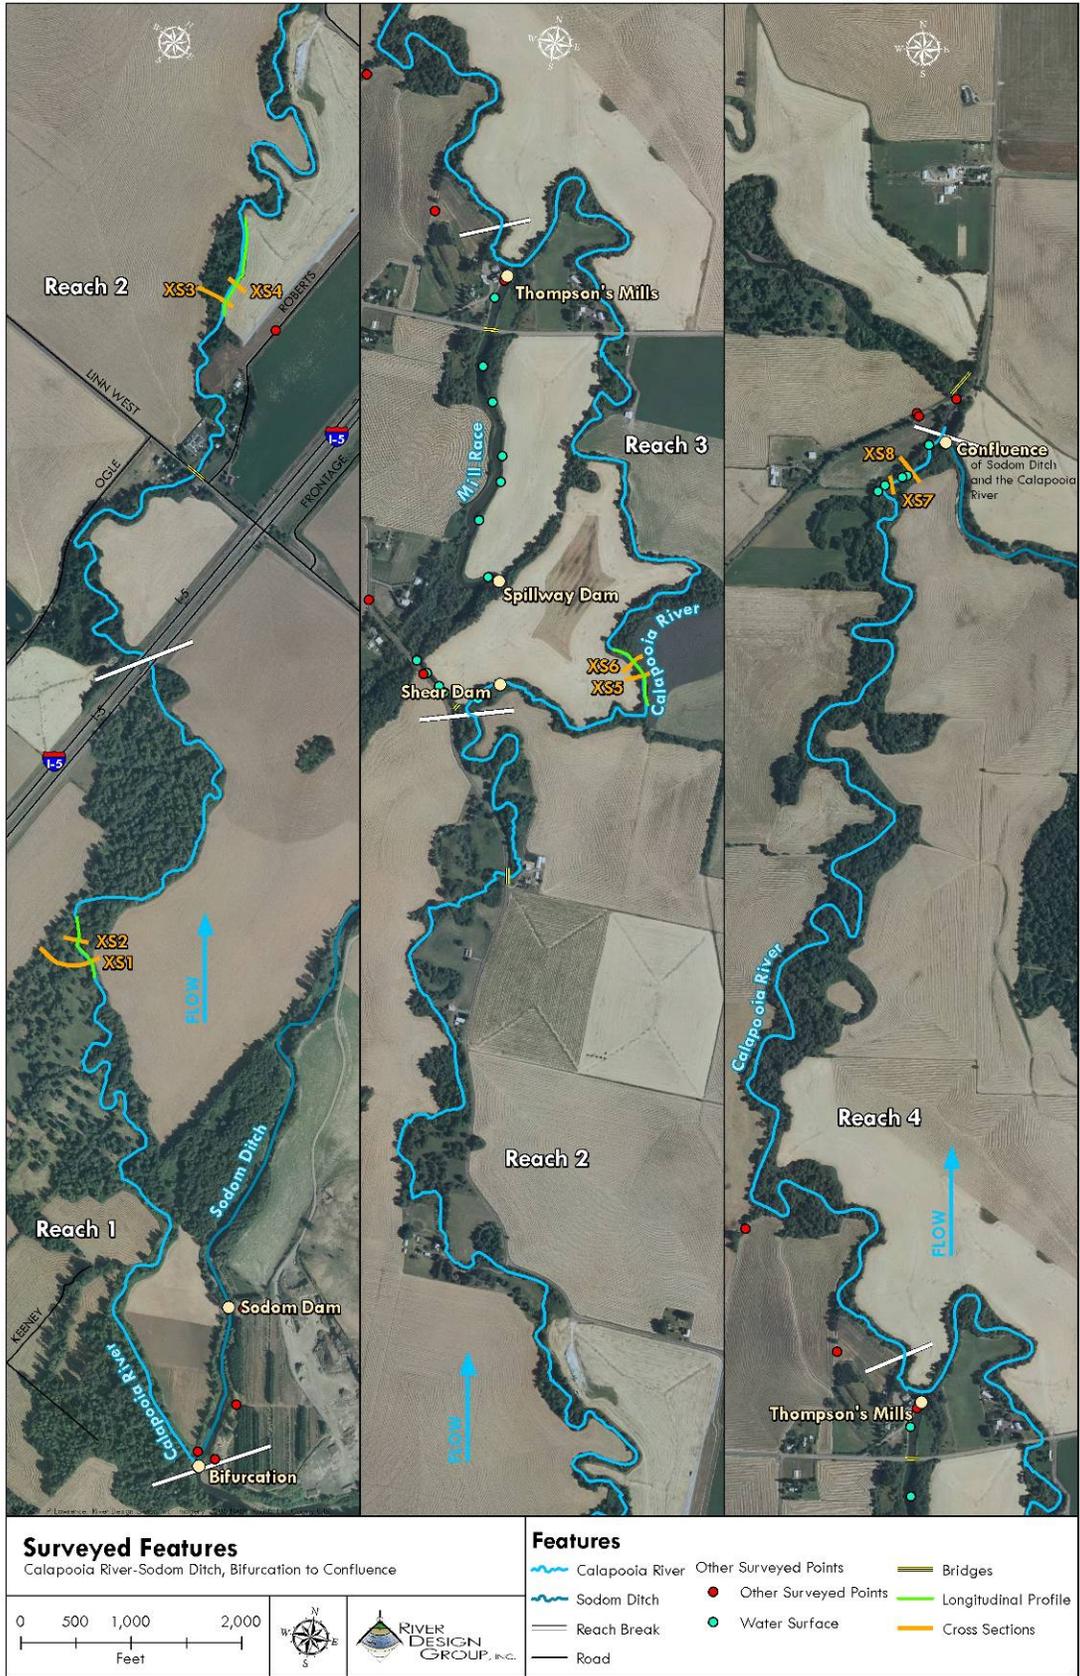
Figure 4-13. Survey locations in the Calapooia River project area.

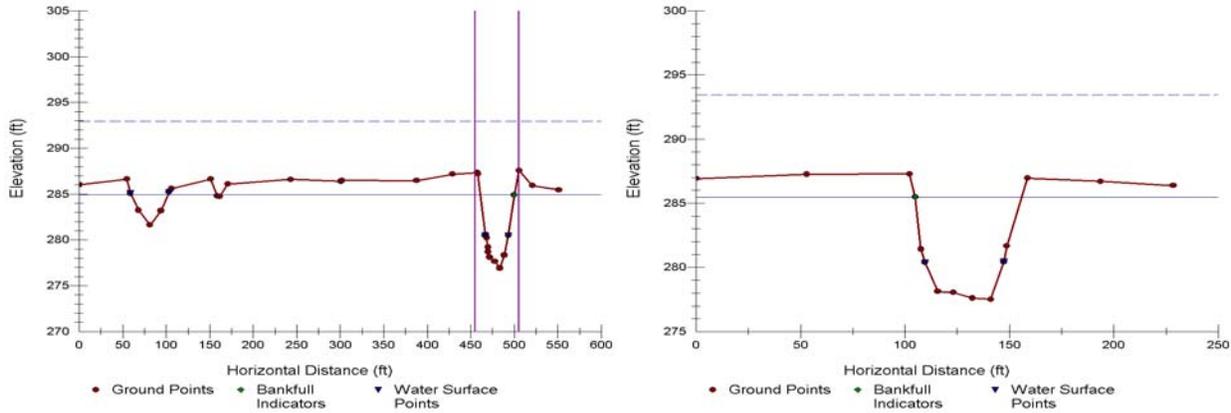
**Figure 4-14.** Typical channel cross-sections in Reach 1. R1XS1 (left) is located at STA 1+50 and R1XS2 (right) is located at STA 3+98 on the Reach 1 longitudinal profile. R1XS2 is more entrenched and maintains a larger cross sectional-area.

The channel morphology in Reach 1 is characterized silt-clay dominated, plane bed river. The altered flow regime resulting from the split flow condition and management of both the bifurcation and Sodom Dam has modified the magnitude and duration of channel-forming flows in the Calapooia River. These changes are expressed in the morphology and riparian vegetation patterns. Figure 4-14 displays the typical cross-section morphology of the valley (left cross-section) and channel (right cross-section) in Reach 1. Oxbow meander features are present on terraces bordering the Calapooia River (R1XS1 between STA 0+50 and STA 1+00). Based on hydraulic modeling, these features are likely activated periodically during moderate to high flow events. Based on the surveyed valley cross-section and difference in elevation between the elevation of the oxbow meander and existing Calapooia River streambed, the Calapooia River may have been mechanically dredged (Figure 4-11, R1XS2) to lower the base elevation and/or channelized to optimize agricultural production on the south side of the river corridor. Figure 4-15 illustrates typical river corridor conditions in Reach 1.

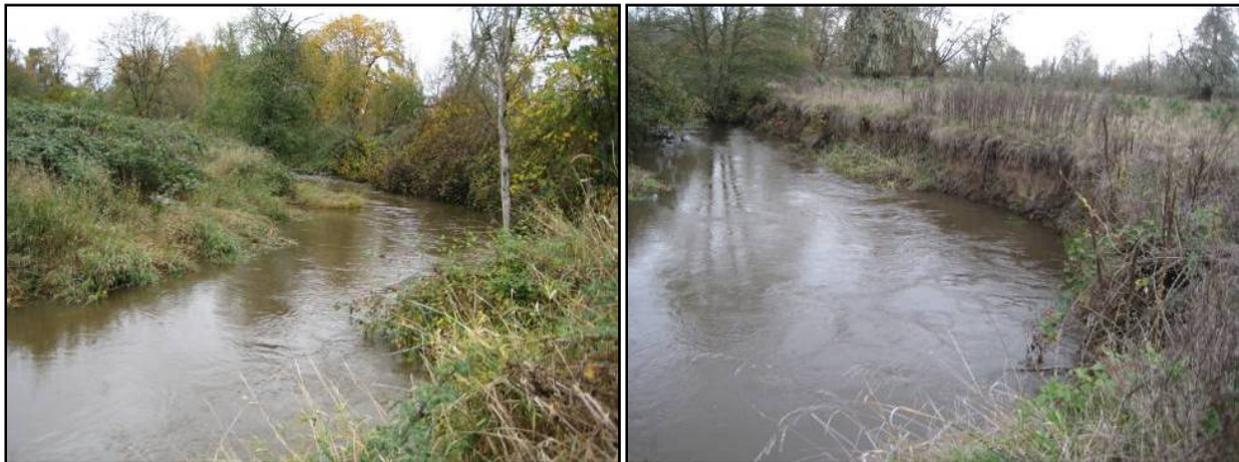
**Figure 4-15.** Typical channel conditions (left) and a sediment source (right) in Reach 1. The riparian corridor includes native species, invasive vegetation, and agricultural fields.

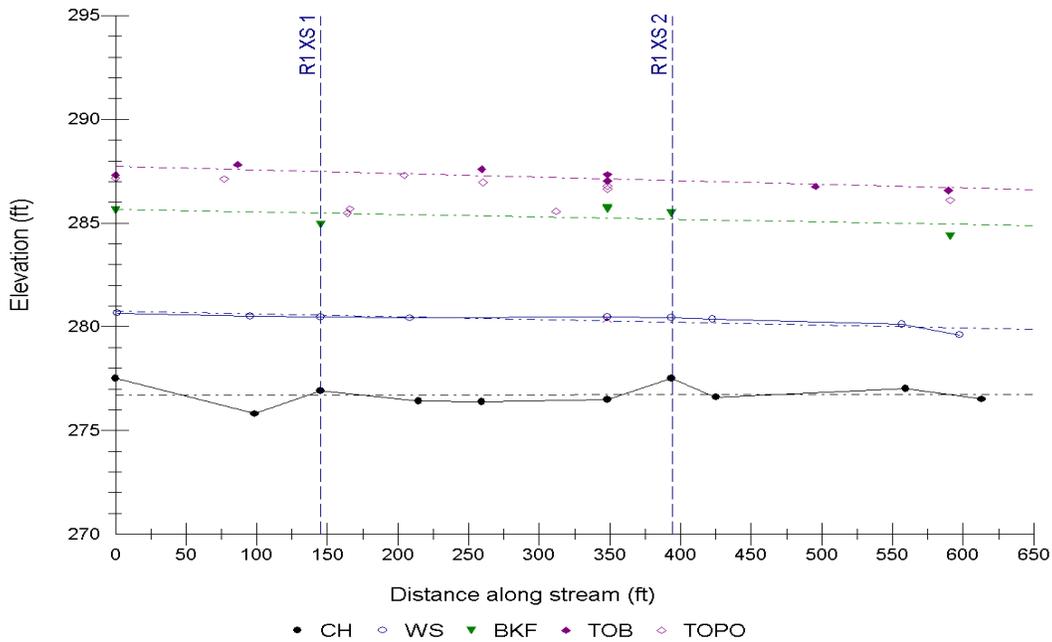
**Figure 4-16.** The longitudinal channel profile for Reach 1 showing the location of cross sections R1XS1 and R1XS2. Profile points include the channel thalweg, water surface, bankfull feature, top of bank, and other topographic points.

Bedforms in Reach 1 of the Calapooia River consist primarily of elongated riffles with marginal pools formed on the outside of meander bends and at hydraulic constriction points formed by large wood (Figure 4-16). The profile encompasses approximately 650 ft and includes channel thalweg, water surface, bankfull, and terrace elevations. Bedforms are homogenous and lack pool-riffle sequences that are typically present in undisturbed rivers exhibiting pool-riffle morphology similar to the Calapooia River. Pool habitat features were extremely limited in the Reach 1. Channel profile gradients for Reach 1 are presented in Table 4-9.

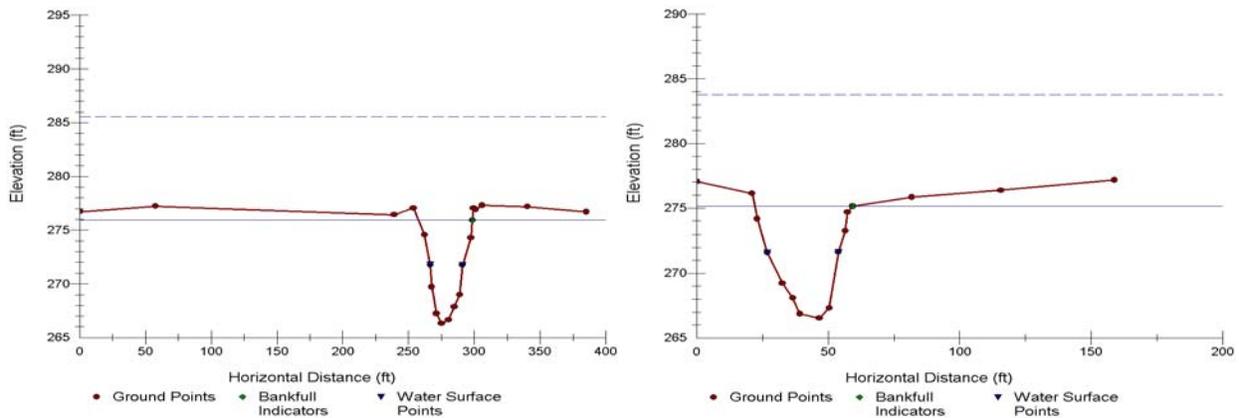
**Figure 4-17.** Typical channel cross-sections in Reach 2. R2XS3 (left) is located at STA 1+30 and R2XS4 (right) is located at STA 3+25 on the Reach 2 longitudinal profile.

The channel morphology in Reach 2 is characterized by a silt-clay dominated, plane bed stream types. Representative channel cross-sections and one longitudinal profile were completed to characterized existing conditions. The channel and floodplain morphologies and riparian vegetation communities reflect the altered streamflow and sediment regimes. Compared to Reach 1, channel cross-sectional area is decreased by approximately 15 percent due to the extensive channel blockages, diffuse flow patterns, and vegetation encroachment on the active channel. Figure 4-17 and Table 4-11 include typical channel cross-sections in Reach 2 and summary bankfull channel metrics. Entrenchment ratios ranged from 4.3 to 9.5, indicating a high degree of channel-floodplain connectivity for the prevailing streamflow regime. Ground photos capturing example river corridor conditions in Reach 2 are presented in Figure 4-18.

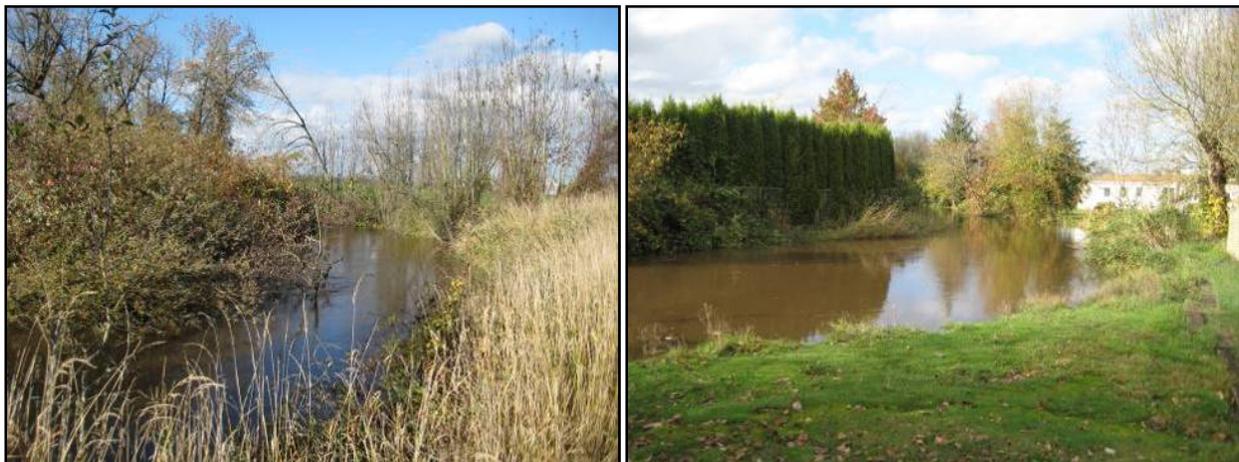
**Figure 4-18.** Typical channel conditions (left) and an example of a floodplain residence (right) in Reach 2. The riparian corridor includes native species, invasive vegetation, agricultural fields, and residential landscaping.

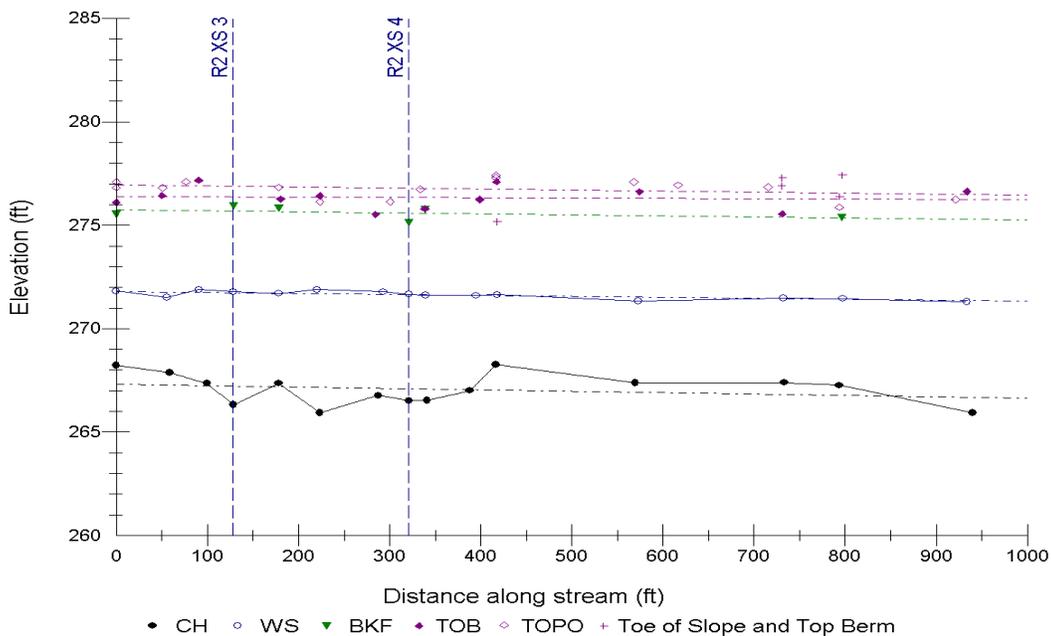
**Figure 4-19.** The longitudinal channel profile for Reach 2 showing the location of cross sections R2XS3 and R2XS4. Profile points include the channel thalweg, water surface, bankfull feature, top of bank, and other topographic points.

Bedforms in Reach 2 of the Calapooia River consisted primarily of homogenous, extended riffle and run features. Due to vegetation encroachment and the diffuse flow network, pools were limited and primarily filled with fine sediment. Figure 4-19 includes a representative longitudinal profile in Reach 2. The profile encompasses approximately 1,000 ft of channel and reflects thalweg, water surface, bankfull and top of bank features. Average thalweg, water surface and bankfull slopes in the project reach were 0.00236 ft/ft, 0.00045 ft/ft and 0.00049 ft/ft, respectively (Table 4-12). Channel velocities averaged 2.0 fps for both observed and modeled bankfull discharge.

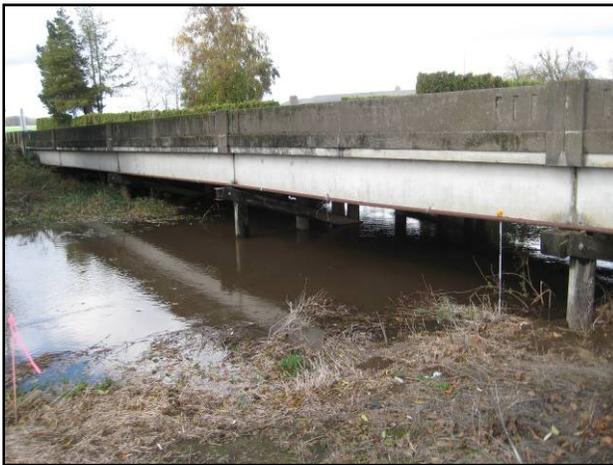
**Figure 4-20.** Linn West Road Bridge No. 12551 is located in the upper section of Reach 2 near the intersection Linn West Road and Roberts Road. The bridge is supported by four wooden piers that obstruct flow and reduce the hydraulic capacity of the bridge inlet.

The measured bankfull width upstream of the bridge was 42 ft. Based on a span width of 130 ft, the bridge likely provides adequate hydraulic capacity for the modeled flood series of the Calapooia River. Recent filling of the right floodplain surface was observed during the field reconnaissance.

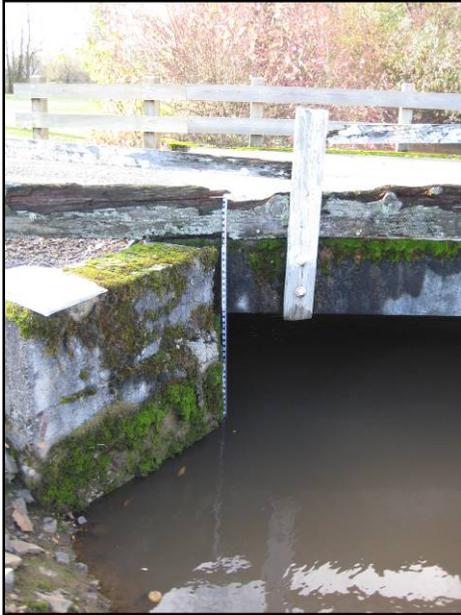
**Figure 4-21.** The Harrison Bridge is constructed of concrete decking and abutments. Based on the measured span, freeboard, and bankfull channel width upstream of the bridge, the structure is significantly undersized and would need further evaluation if alternatives to increase streamflow to the Calapooia River are considered.

upstream channel width measured 48 ft. The bridge span measured only 36 ft resulting in a bridge constriction ratio of 0.75. The floodplain is blocked by the bridge approach grades. Bridge freeboard, measured from the low chord elevation to the estimated bankfull water surface elevation was 2.5 ft. During the field survey, the water surface was within 2.0 ft of the bridge deck.
