# CALAPOOIA RIVER GEOMORPHIC ASSESSMENT

## SODOM DAM BIFURCATION TO BUTTE CREEK CONFLUENCE

**DRAFT** May 2009

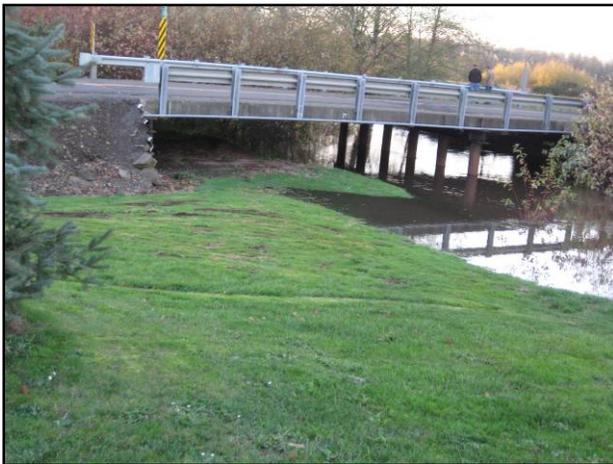
**Figure 4-22.** Roberts Road Bridge No. 12556 consists of a concrete deck, steel piers and abutments. The bridge provides adequate span for the existing streamflow regime. Hydraulic analyses would be required if future alternatives consider increasing streamflows to the Calapooia River.

Roberts Road Bridge No. 12556 crosses the Calapooia River approximately 0.5 miles upstream of Shear Dam and the inlet to the Thompson's Mills millrace. The bridge spans 70 ft and consists of a concrete deck, steel piers and abutments (Figure 4-22). The bridge is supported by a pier consisting of six steel piles located in the center of the channel cross-section. The channel width upstream of the bridge is 40 ft, for an approximate bridge constriction ratio of 1.75. Bridge freeboard, measured from the low chord elevation to the estimated bankfull channel elevation, was 5.0 ft.

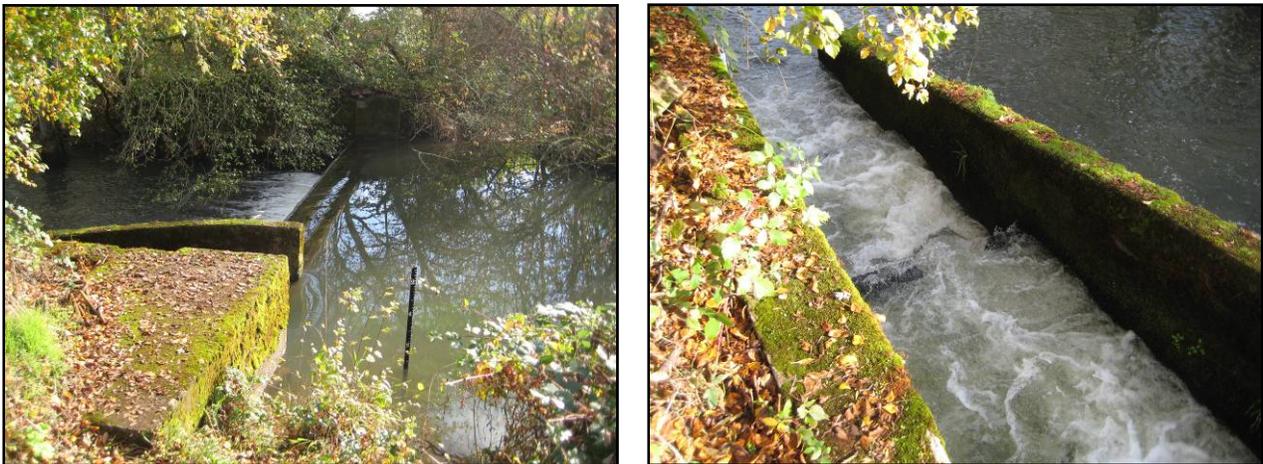
**Figure 4-23.** Existing condition photos of Shear Dam (left) and associated pool and weir fish ladder. Hydraulic conditions likely impede fish passage during certain flow stages.

Figure 4-23 includes photographs of Shear Dam and the pool and weir fish ladder. While a detailed model of the existing dam was not completed to evaluate fish passage capabilities, it is presumed that the structure is a partial fish passage barrier for certain life histories stages of fish.

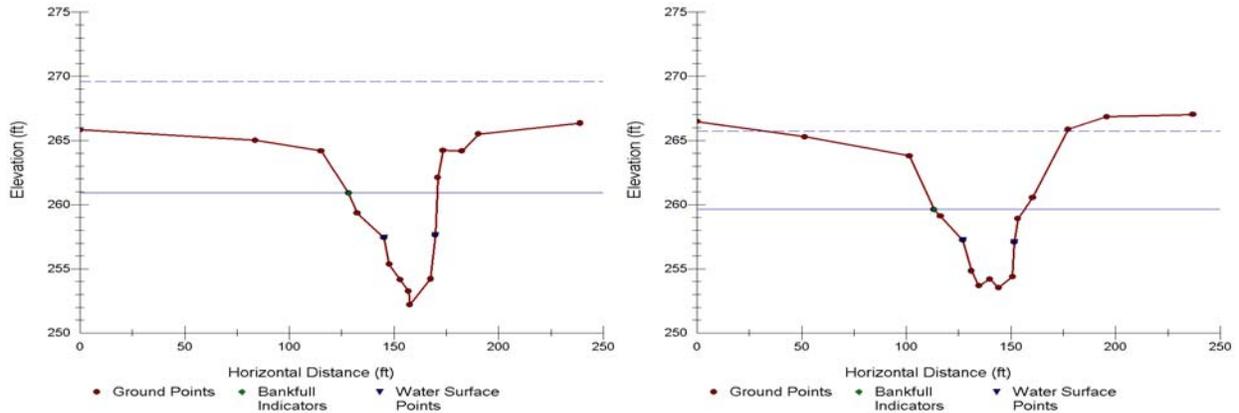
**Figure 4-25.** Typical channel cross-sections in Reach 3. R3XS5 (left) is located at STA 2+60 and R3XS6 (right) is located at STA 4+25 on the Reach 3 longitudinal profile.

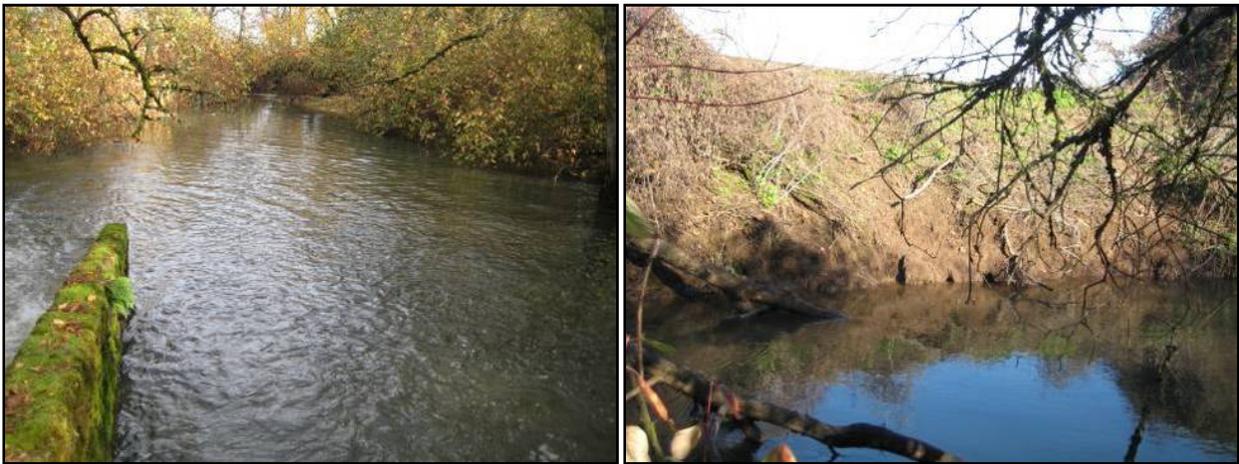
**Figure 4-26.** The Calapooia River in Reach 3 including a view downstream of Shear Dam (left) and an example vertical eroding bank with poor riparian vegetation coverage (right).

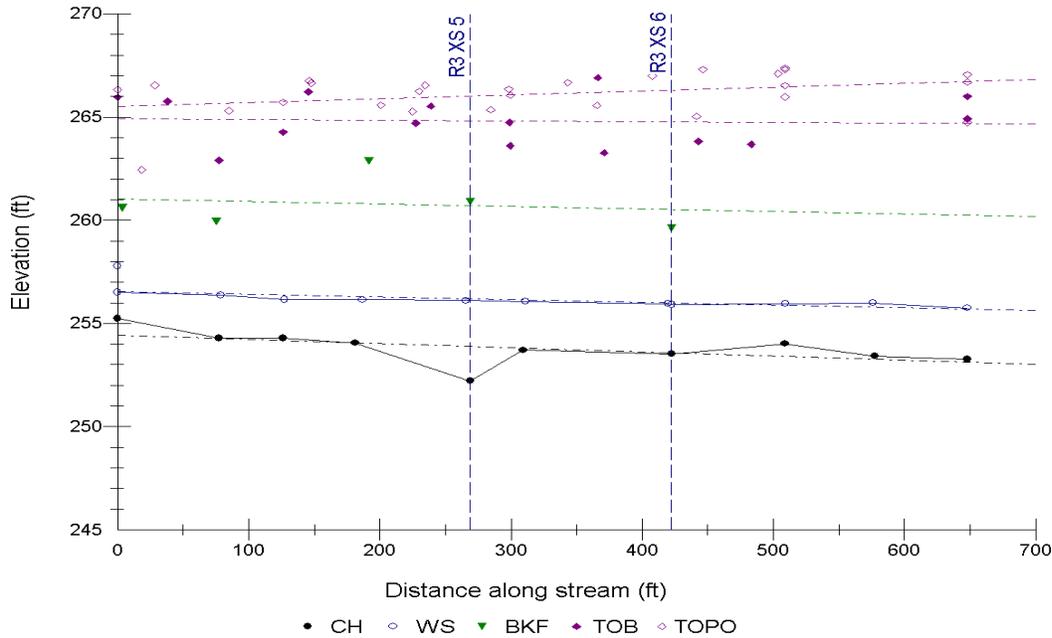
**Figure 4-27.** The longitudinal channel profile for Reach 3 showing the location of cross sections R3XS5 and R2XS6. Profile points include the channel thalweg, water surface, bankfull feature, top of bank, and other topographic points.

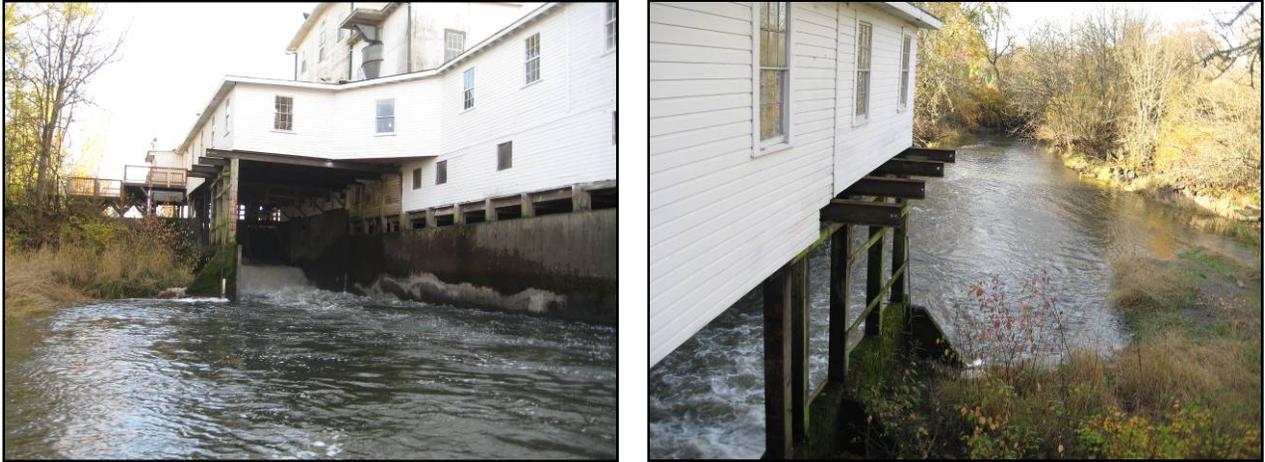
**Figure 4-28.** The Thompson's Mills spillway and mill denote the downstream terminus of Reach 3. The left photo shows the spillway from the spillway confluence with the Calapooia River. The right photo includes the confluence of the spillway and the Calapooia River and the start of Reach 4. The right photo was taken standing next to the spillway shown in the left photo.

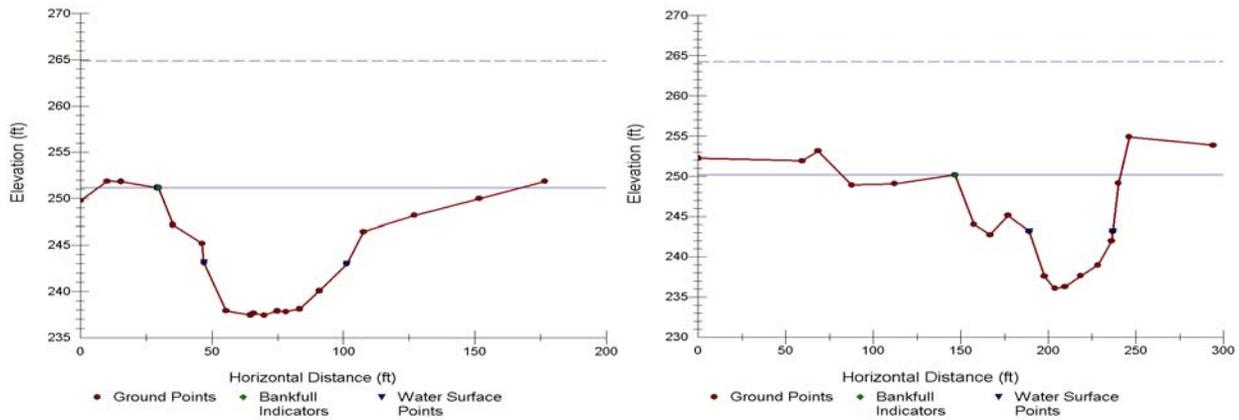
**Figure 4-29.** Typical channel cross-sections in Reach 4. R4XS7 (left) is located at STA 2+60 and R4XS8 (right) is located at STA 4+25 on the Reach 4 longitudinal profile.

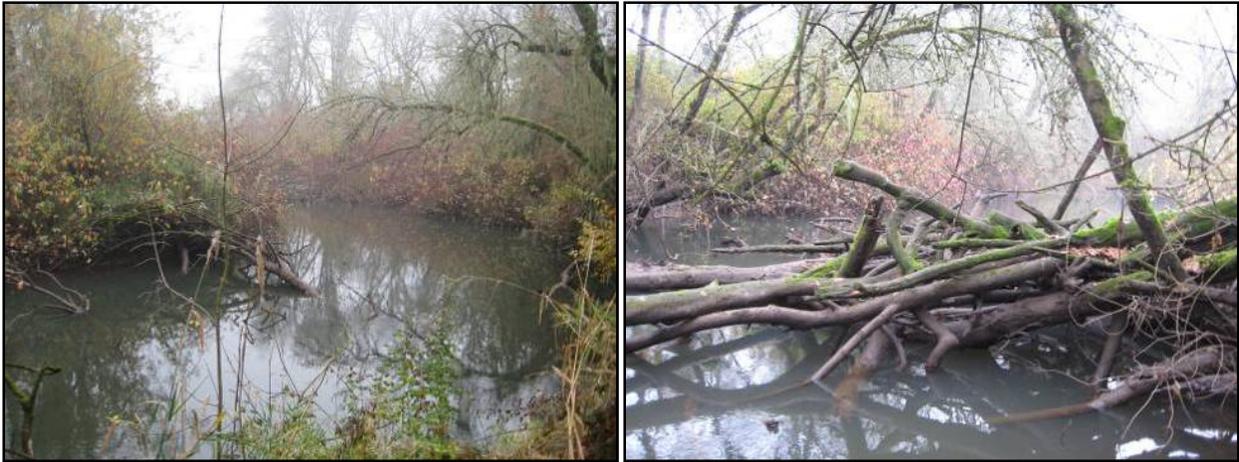
**Figure 4-30.** Typical channel conditions in Reach 4 (left) and an example large wood array (right).

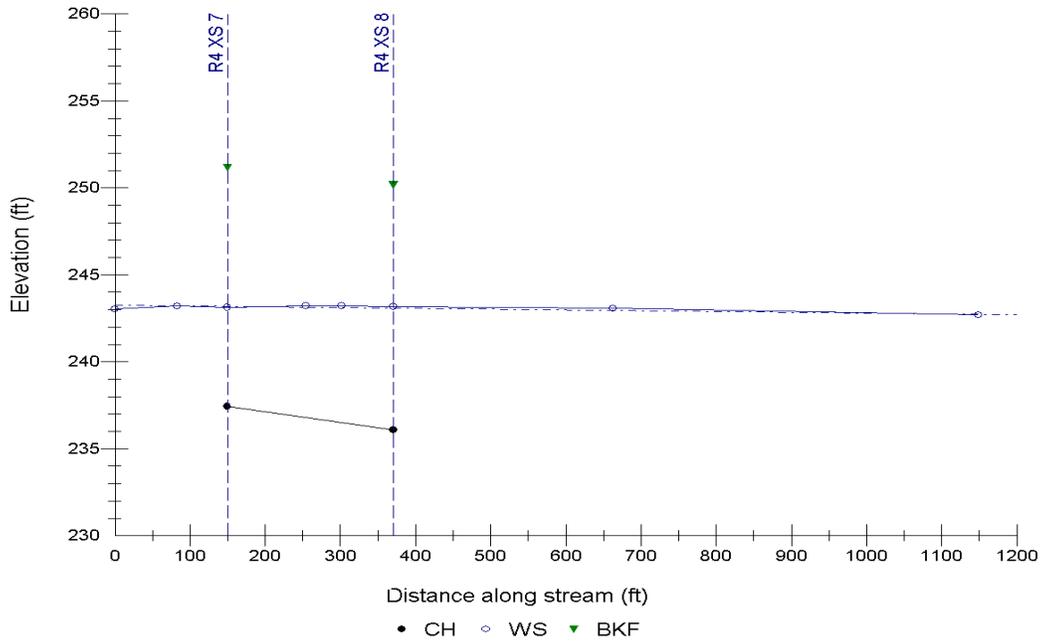
**Figure 4-31.** The longitudinal channel profile for Reach 4 showing the location of cross sections R4XS7 and R4XS8. Profile points include the channel thalweg, water surface, bankfull feature, top of bank, and other topographic points. The Reach 4 water surface slope was 0.00043.

The channel profile in Reach 4 was limited by vegetation conditions and water depth. A water surface profile was completed in order to develop the cross-section hydraulics for R4XS7 and R4XS8. (Figure 4-31)
