# Albany Area Floodplain Habitat and Stream Assessment - Stakeholder Team Meeting

# Inundation Model Validation

## Harken's Lake Inundation at 60,000 cfs (Harrisburg)

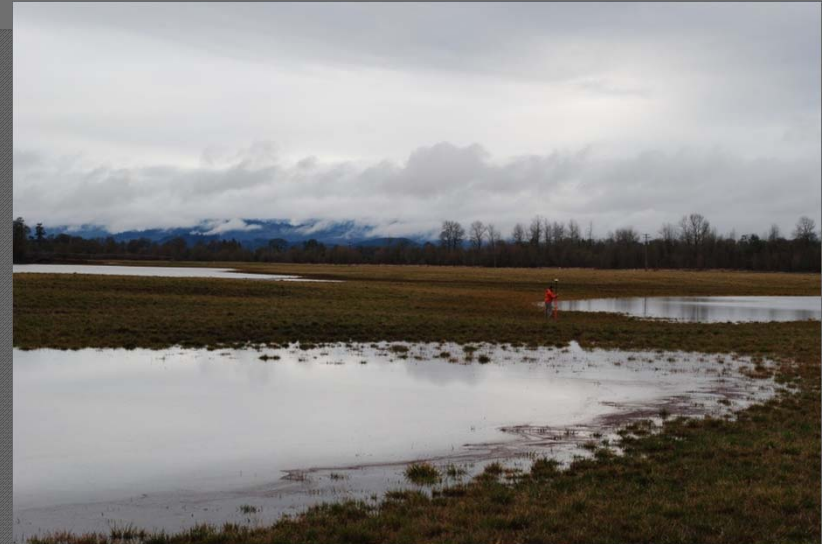
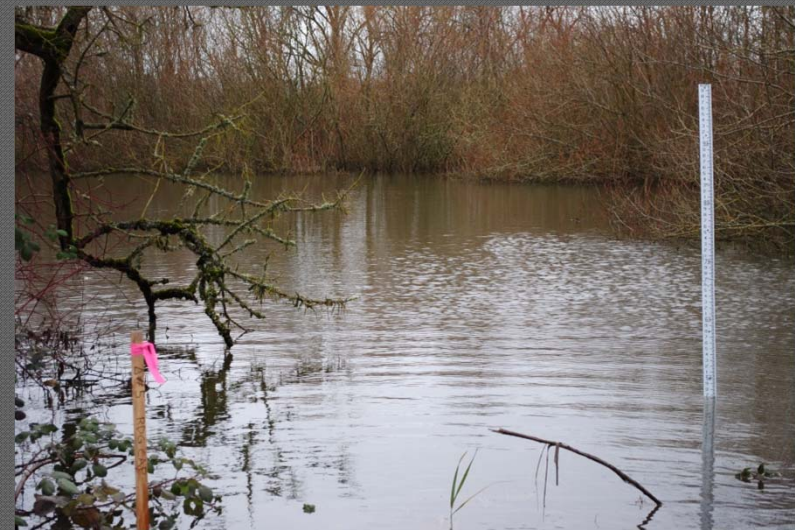
Top panel represents inundation based on measured water surface at center staff gage on 01/17/2011 when Harrisburg gage was at 60,000 cfs. Bottom panel represent inundation based on Willamette Inundation model for 60,000 cfs at Harrisburg.

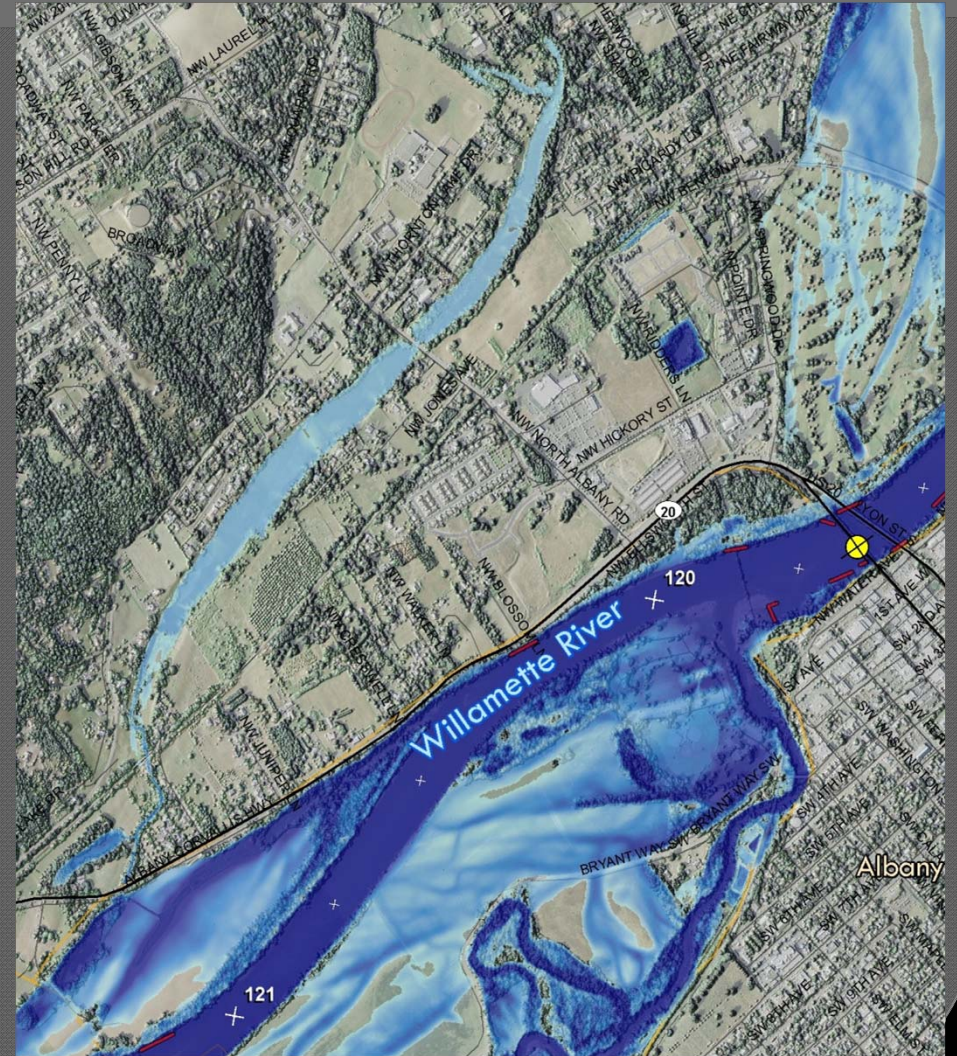
**Thornton Lake Inundation**  
under 2 year regulated flow  
Willamette River, near Albany, OR

Source Data: LIDAR, DOGAMI (from Watershed Sciences 2008-2009), Imagery, 2009 NADIP Anchor Habitats, TNC, Roads, Tele Atlas, Highways, ODOT, Revetments, PNW-ERC, Stream Gages, USGS, Ownership, ODF

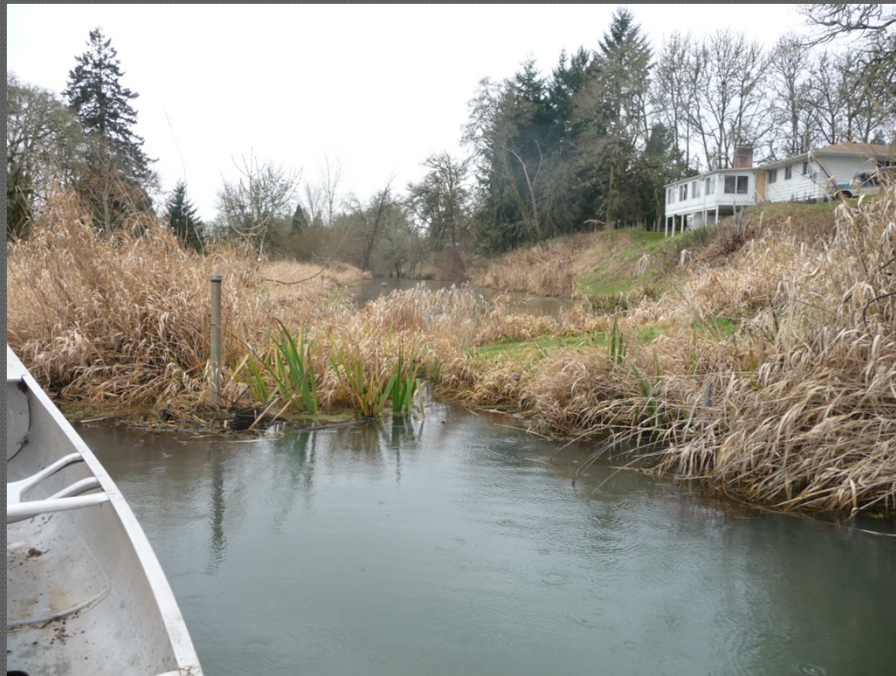
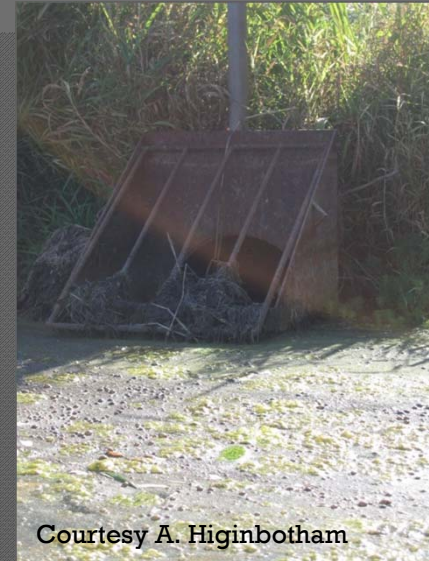
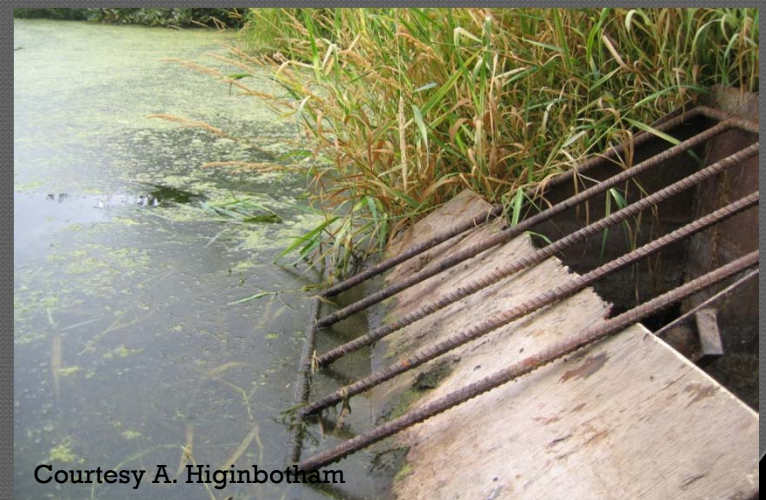
- Lake outlet control structure

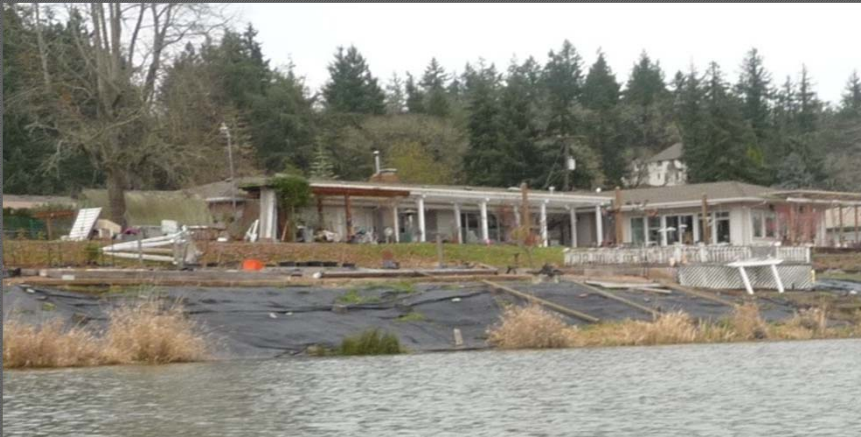
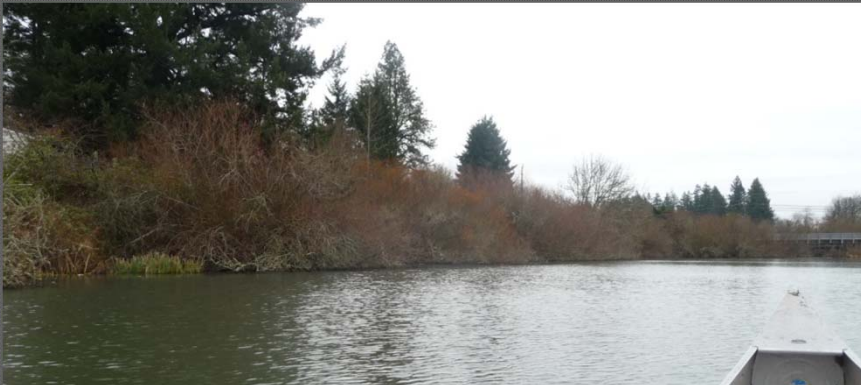
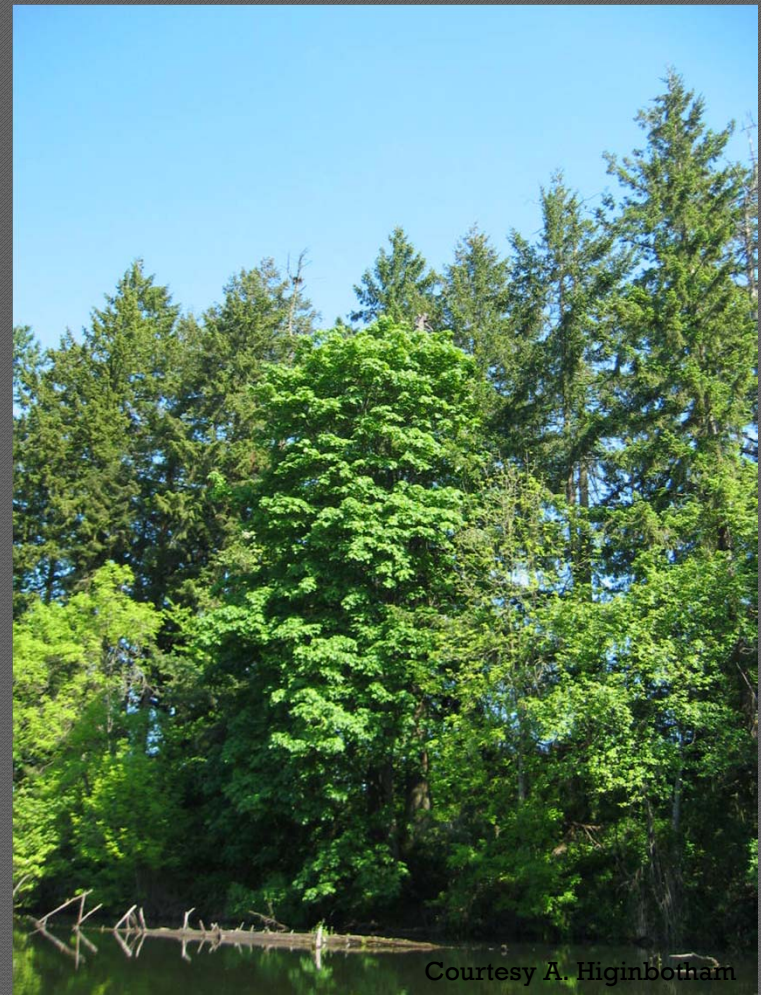
- Example bank conditions

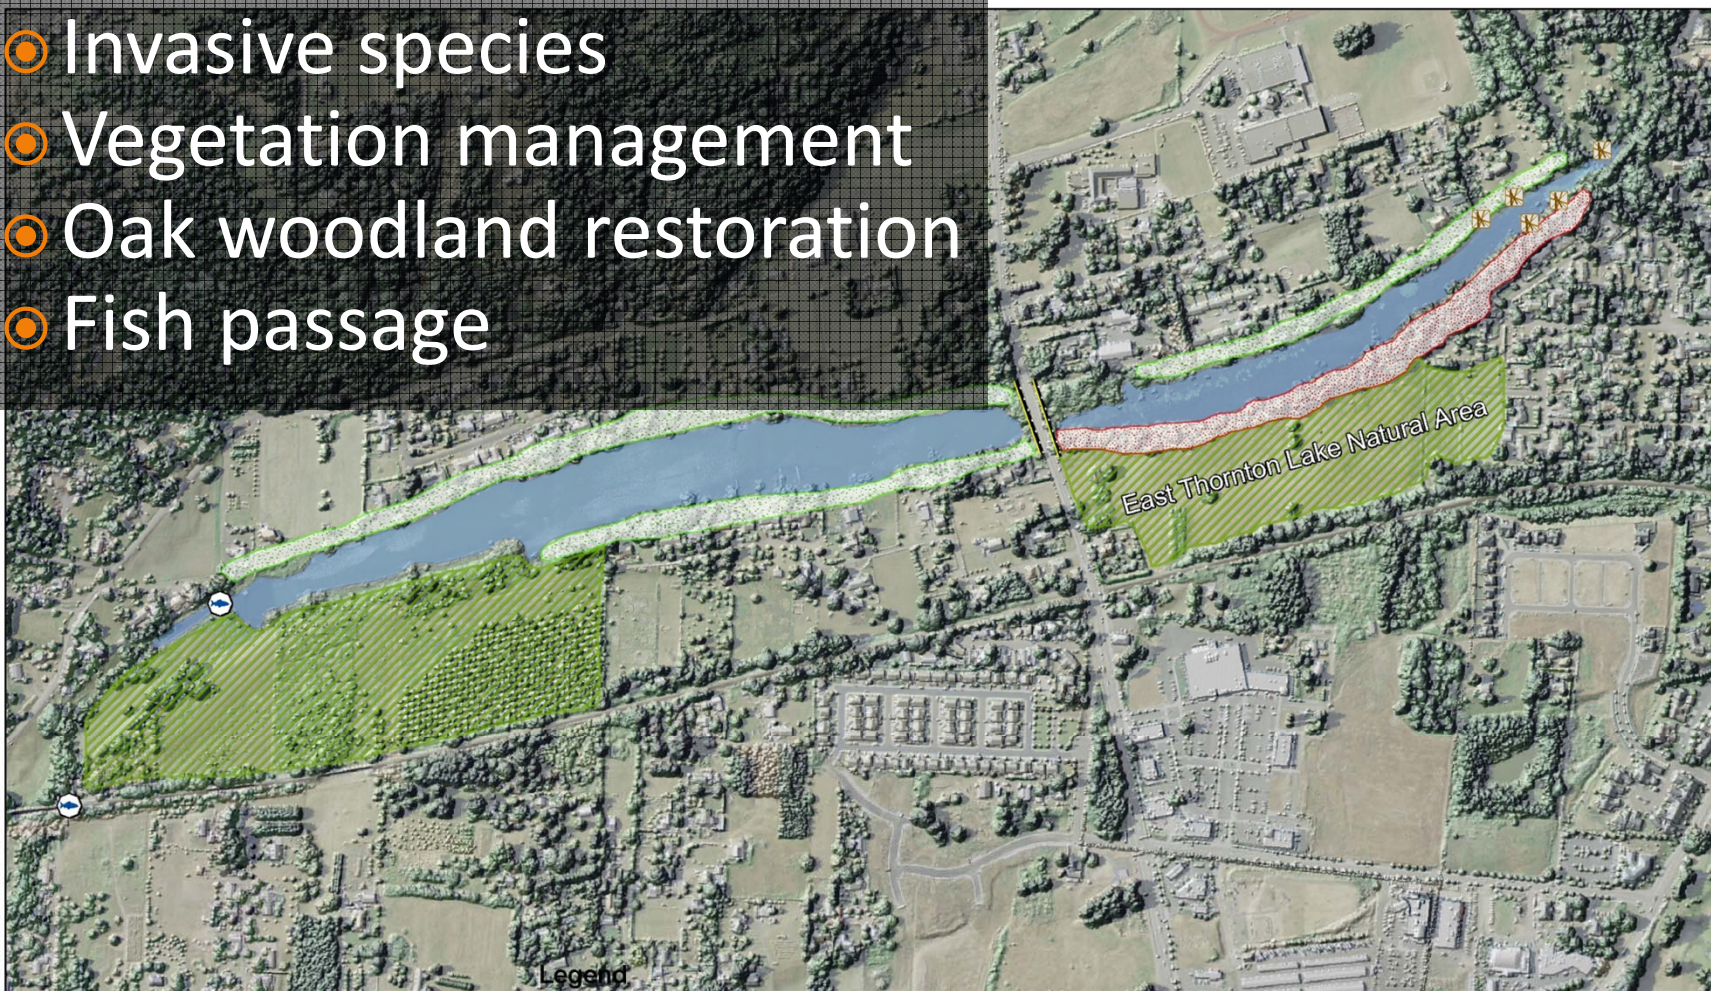
**Thorton Lakes Treatment Map**

bask_logs	strm_mgmt	invsp_mgmt
fish_psg	Veg_mgmt	Riparian
	lakes

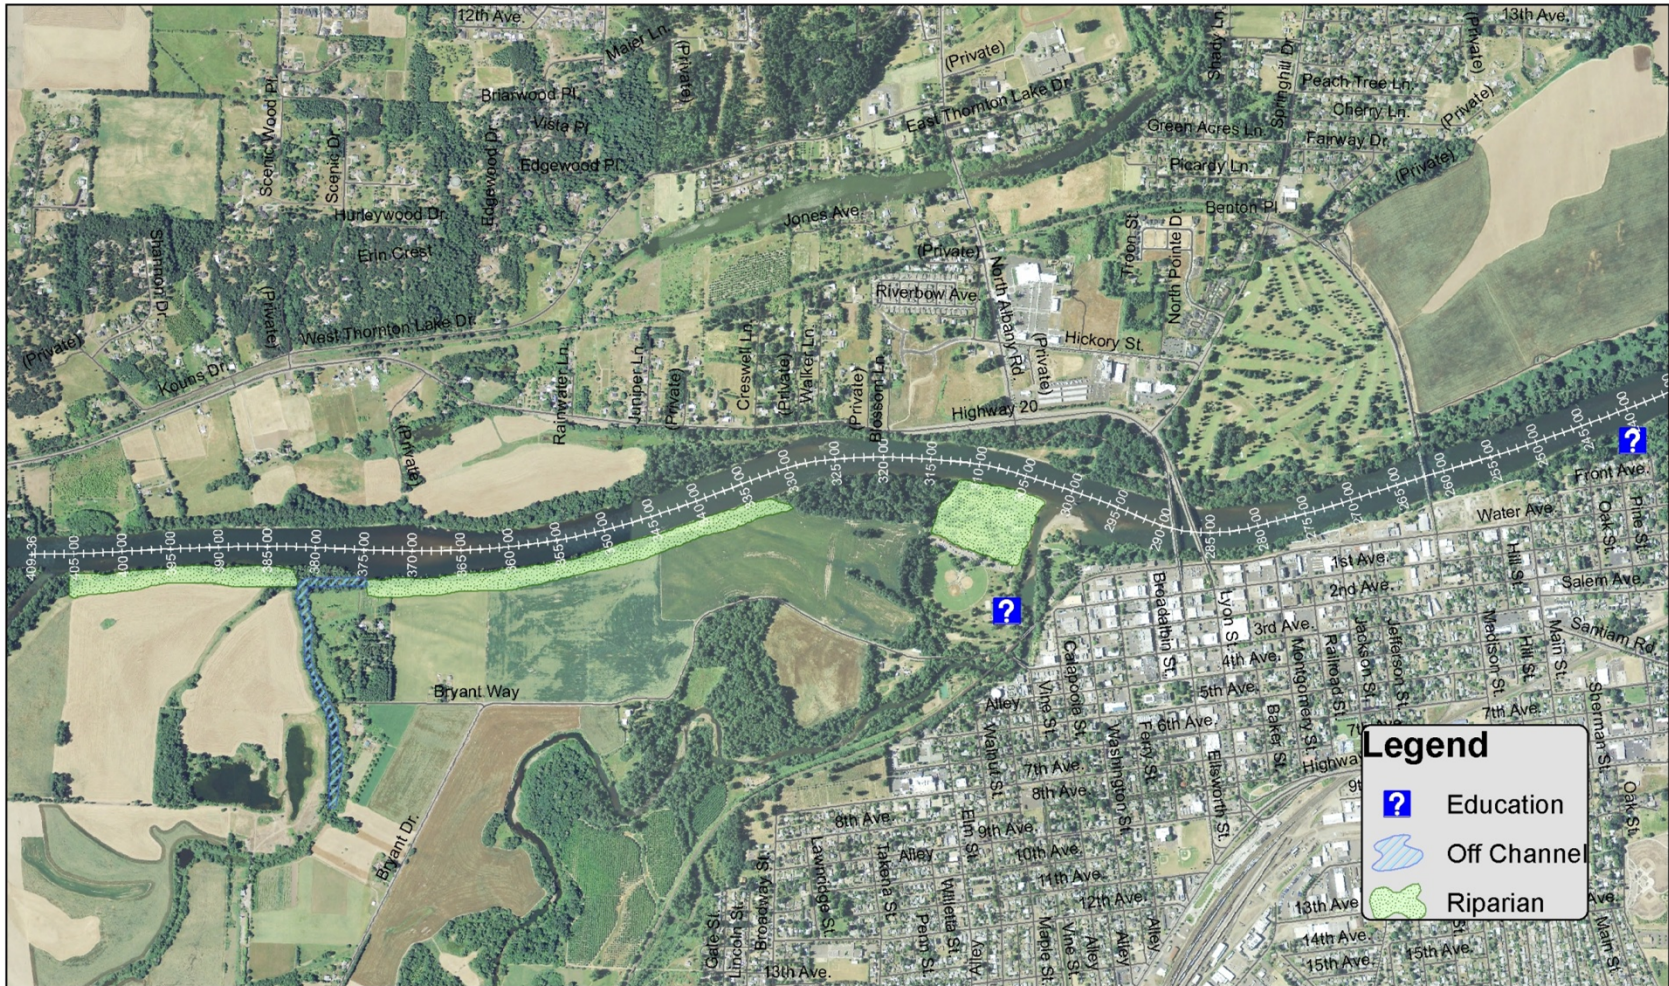
Willamette River, Treatments 1

- Education
- Off Channel
- Riparian
